Port Stanley Observatory Service Report 6 – 11 September 2004

Internal Report IR/05/093

C W Turbitt

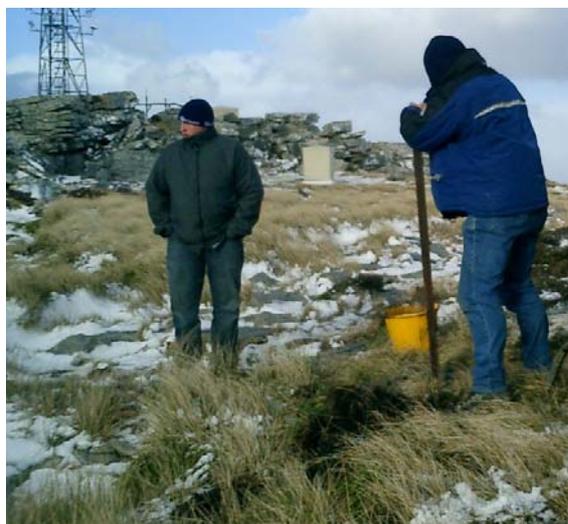
Figure 1 Auxiliary Fixed Mark

This auxiliary mark is approximately 20 metres from the absolute pillar and such a short baseline probably accounts for the large scatter in the measured bearings, as the bearing is very sensitive to the theodolite position on the tripod.

To solve this problem, another, more distant, mark was established (Figure 1). A two-metre section of angled steel post was mounted vertically in concrete, approximately sixty metres to the west of the absolute hut where it is clearly visible through the observation hatch of the absolute hut.
