# Landslide survey: High Lossit, near Machrihanish Bay, Mull of Kintyre

Internal Report IR/14/035

R Ellen and K Whitbread

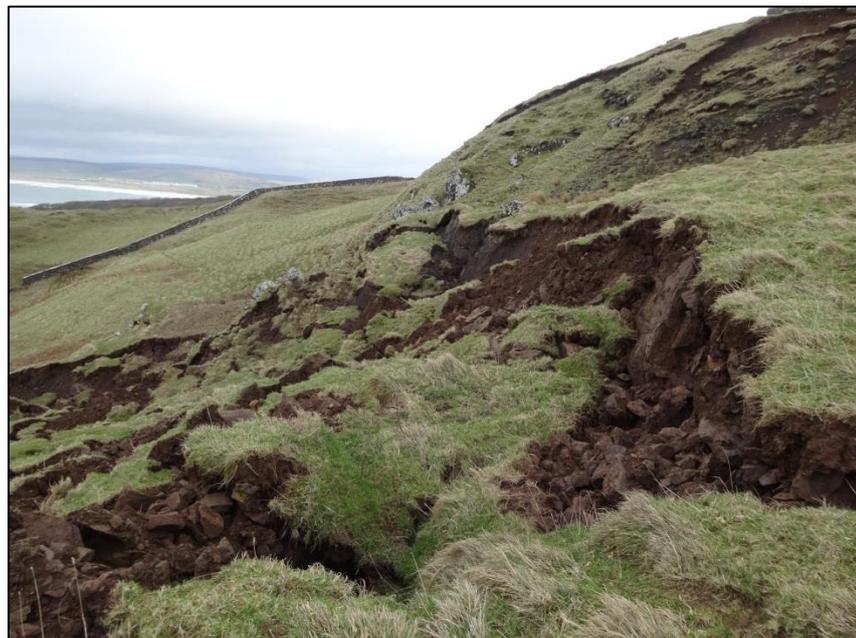
Back scarp and related deformation of the landslide at High Lossit. Photo looking north from [NR 62655, 19980]

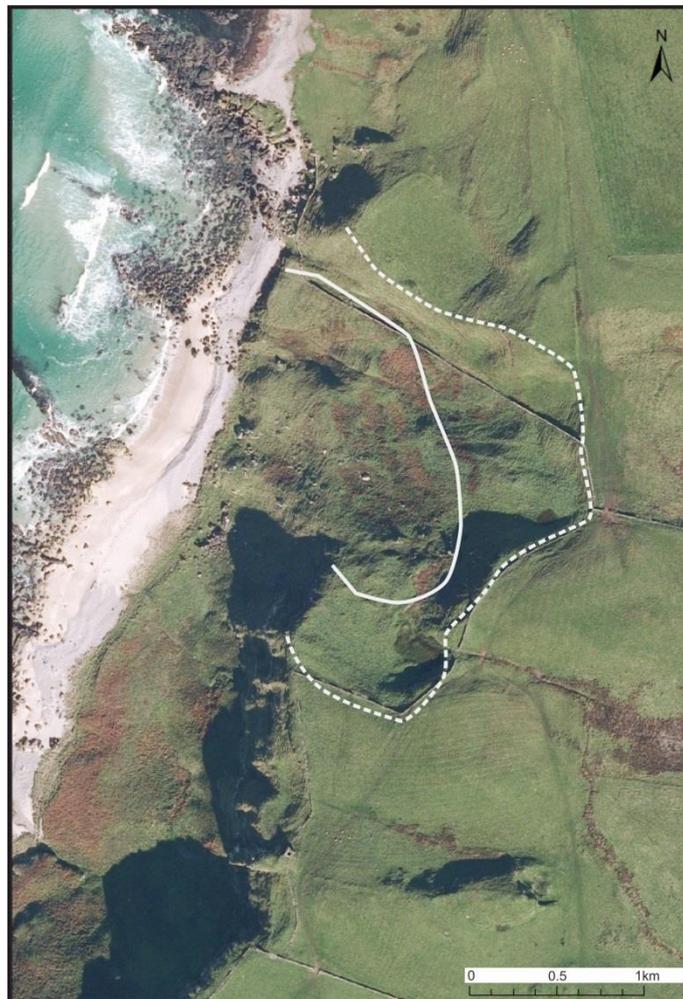
The aerial photograph in Figure 2 (taken prior to the recent landslide) shows that the ground at the site is undulating and rough with large scattered boulders. A distinct morphological break in slope surrounding the new landslide has been highlighted (solid line). The surrounding landscape is characterised by steep slopes, which likely represent the scarp of an older, pre-existing landslide (dashed line). The photograph also shows the central area has a hummocky appearance with boulders lying on the surface.

**Figure 2:** Pre-event aerial photograph (taken c. 2009) of the field at High Lossit, Mull of Kintyre. White dashed line marks location of pre-existing relict landslide scarp, and solid line marks the backscarp formed during the recent landslide event detailed in this report. Note also that the cliff line toward the south represents a former shore line, with a distinctive raised beach between the cliff and the modern foreshore. *Aerial photograph © Getmapping: Licence Number UKP2006/01.*

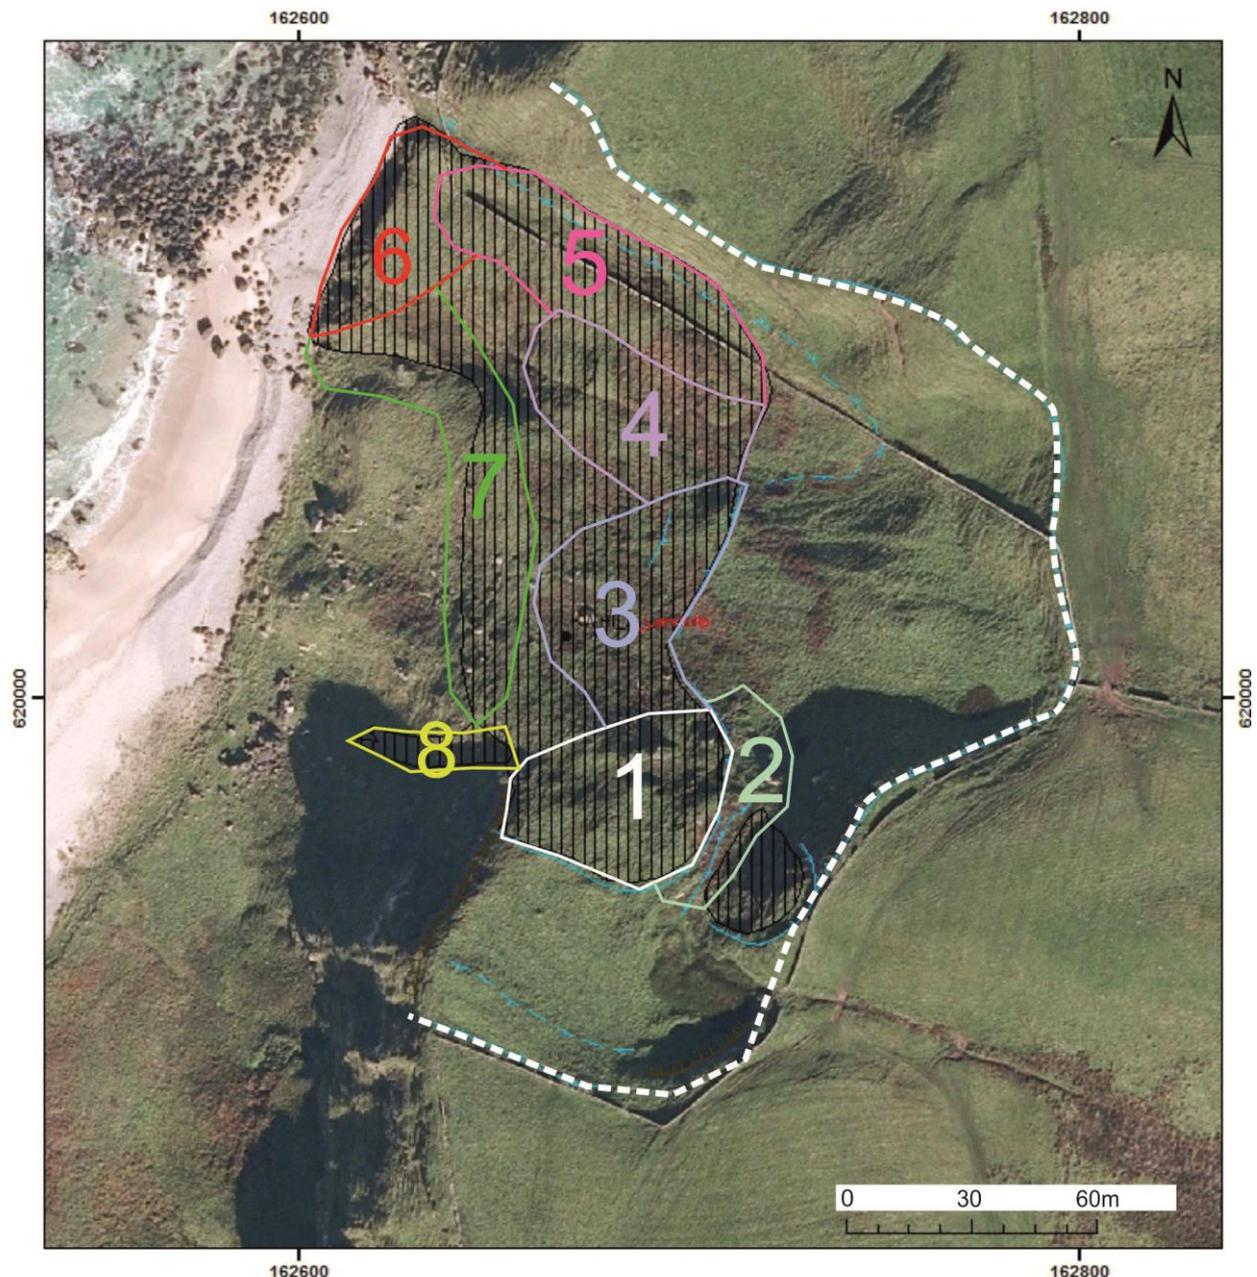
**Figure 4:** Aerial photograph showing extent of recent landslide ground movement (hatched area) at High Lossit. Regions 1-8, described in the text, are numbered. Blue lines represent breaks in slope, and outline the top of the scarps of both the recent landslide and pre-existing landslides. *Aerial photograph © Getmapping; Licence Number UKP2006/01.*

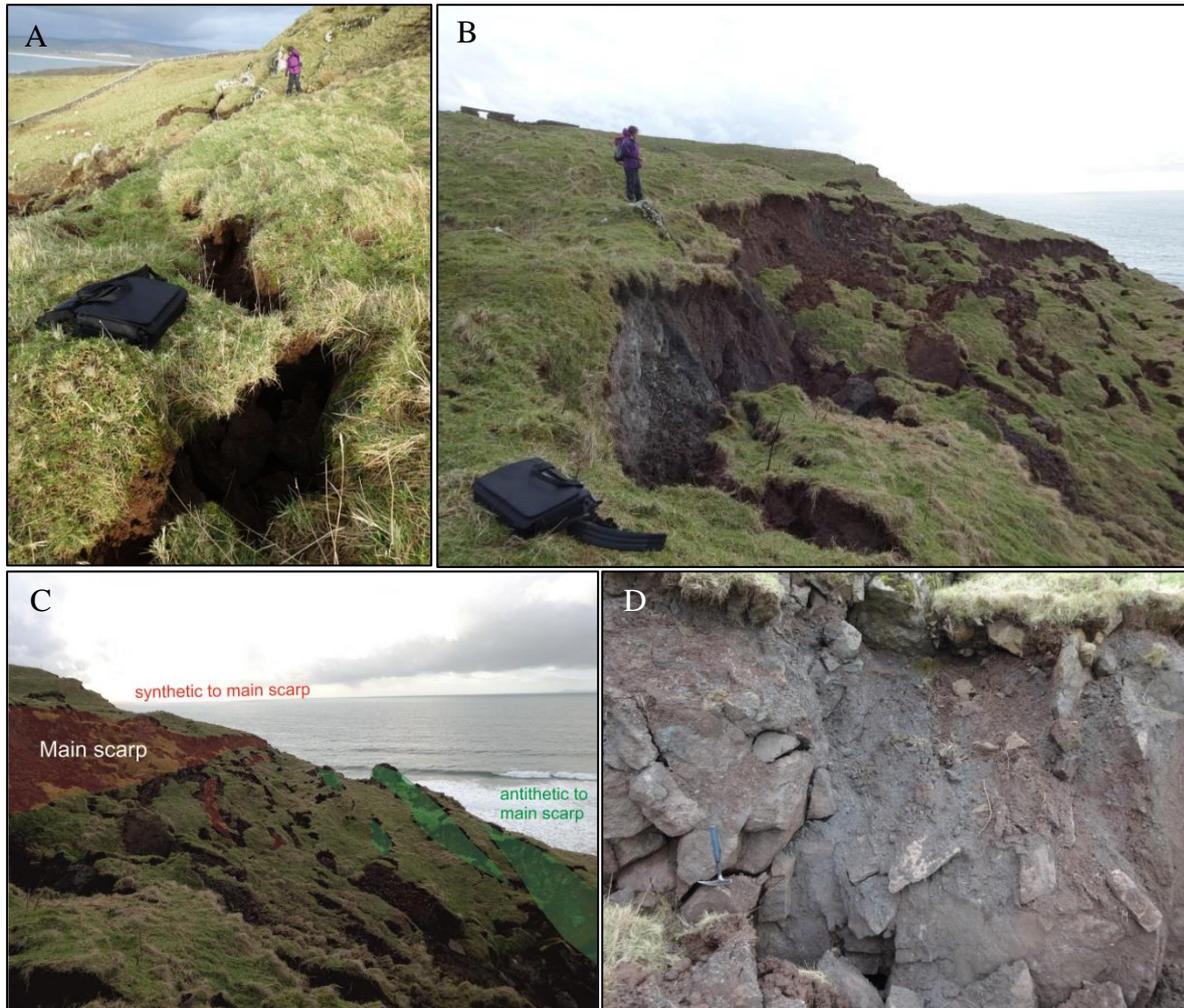
1. Up to 5 m beyond the main scarp of the slip, the crown of the recent landslide contains open tension cracks aligned parallel to the main back scarp (Figure 5a). The tension cracks are at least 3 m in length, with at least 10 cm vertical displacement, in places up to 50 cm.

2. A curvilinear, continuous main scarp, (shown in Figure 5b) marks the southern-most extent of the recently active landslide. The main scarp shows a normal offset of 3 – 4 m, with open fissures extending for an unknown depth below the surface. For the most part these fissures at the base of the scarps are filled with loose debris. The main scarp feature has a slope of  $>70^\circ$  and faces north.

3. The area of ground immediately below the main scarp is severely deformed, with numerous synthetic, low displacement ( $<1$  m) scarps occurring within a few metres of the main scarp, and higher displacement ( $>1$  m,  $<1.5$  m) antithetic scarps extending up to 20 – 25 m away from the main scarp (Figure 5c). In this zone of deformation, boulders have been rotated downslope (to the north) by at least  $50^\circ$ , still with an apparent normal displacement (i.e. no lateral movement).

4. The landslide material in Region 1 consists typically of large boulders of CPV-BAOM, c. 1 – 3 m in diameter, within a matrix of sandy clay with abundant boulders, cobbles and gravel of CPV-BAOM basalt (Figure 5d).

**Figure 5: Features in Region 1:** a) Tension crack in rear scarp of recent landslide (photo facing north east). b) Detail of north facing main scarp, exposing grey slope debris composed of angular boulders of basalt in a brown sandy clay matrix. c) Zone of deformation immediately north of main scarp, containing synthetic and antithetic minor scarps. Photo facing west. d) Detail of slope debris exposed in main scarp composing zone of deformation. Note angular boulders are weathered basalt. Photo facing south.

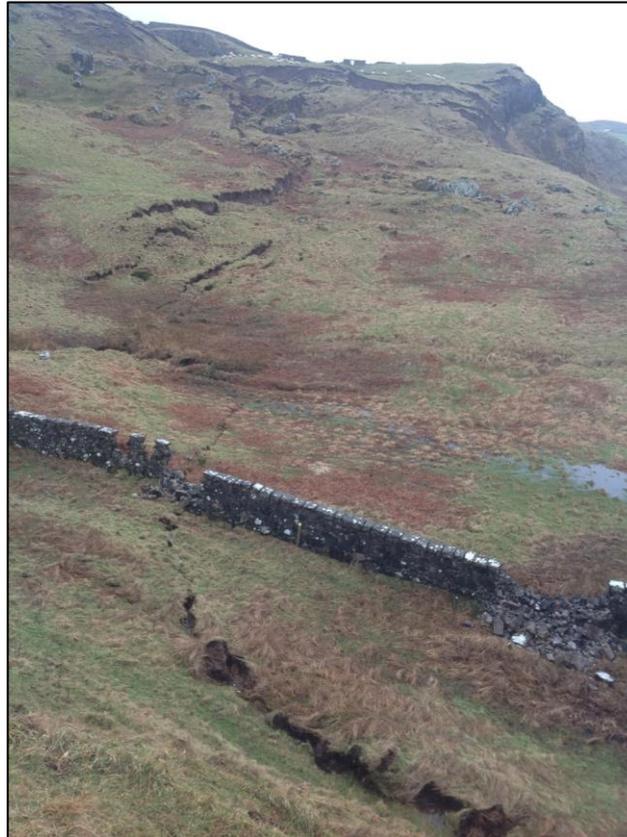
**Figure 6:** Overview of the eastern flank minor scarp. Photo looking toward the south. Taken by Adam Armour on 5<sup>th</sup> February 2014.

1. The main scarp on the eastern flank (Figure 6) shows a normal offset of 1 – 2 m displacement, with evidence for lateral dextral movement of at least 1 m. Two very large boulders, which were originally in line with each other on the c. 2009 aerial photography, are very prominently displaced by at least 1 m in a dextral motion.

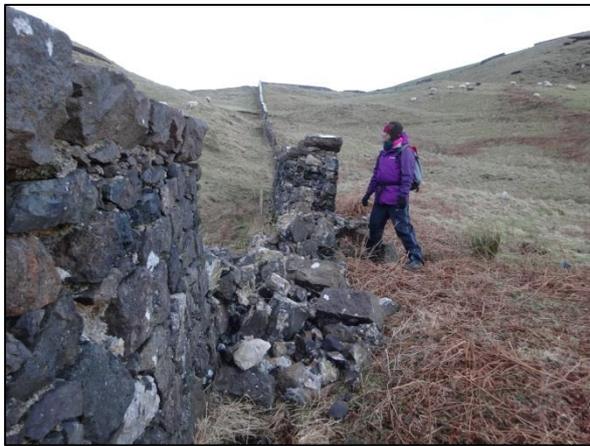
**Figure 7:** Displaced stone wall as a result of landslide movement. The wall has moved c. 1 m in a dextral sense of motion and rotated slightly. Photo facing east.

- The maximum northerly vertical displacement measured at the head of the landslide was 2 – 3 m (measured in displaced scarp material, with a dextral motion), and 1 m at the foot (measured in offset stone wall, also dextral in motion).

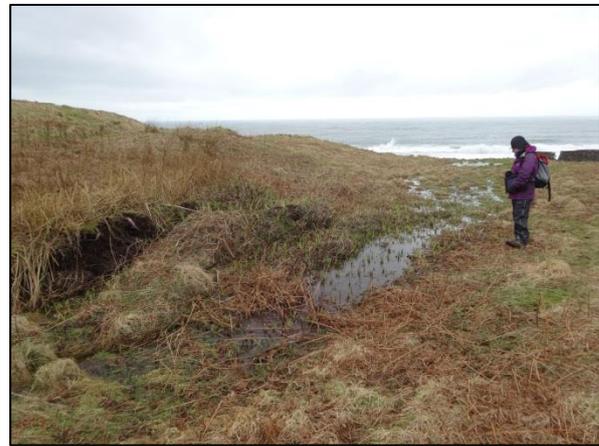
1. The height of the eastern flank minor scarp decreases northward down slope, until the scarp is little more than 10 cm in height at the foot of the landslide. Significant offset across a stone wall (Figure 7) suggests a dextral displacement of up to 1 m has occurred in this location during the recent movement event. This feature indicates a transition zone in the landslide between extension (with subsidence within the landslide mass) and compression (uplift of the mass at the toe).
2. There were also newly formed ‘sag ponds’, with a notable absence of water-loving plants, adjacent to a series of small thrusts forming ‘rucked-up’ ground, indicating compression at the foot of the landslide (Figure 8).

**Figure 8:** Newly formed sag ponds and thrusts in the foot of the landslide. Springs issuing from the toe. Photo facing west.

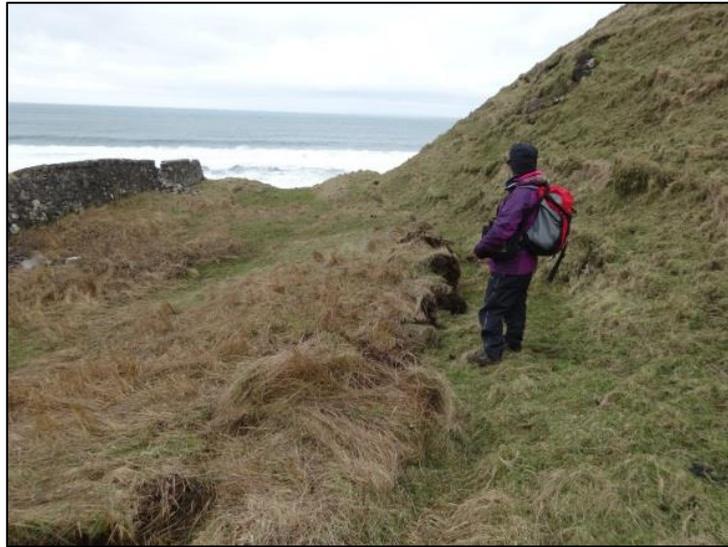
1. Where the landslide material (moving north) meets this southward facing slope, the margin of the landslide is marked by a thrust with c. 20 cm of vertical displacement (Figure 9).
2. Above the landward toe, on the pre-existing scarp slope, there are open tension cracks with a normal displacement, also facing southward.

**Figure 9:** Thrust at landward toe of landslide in Region 5 [NR 62696, 20112]. Photo facing westward.

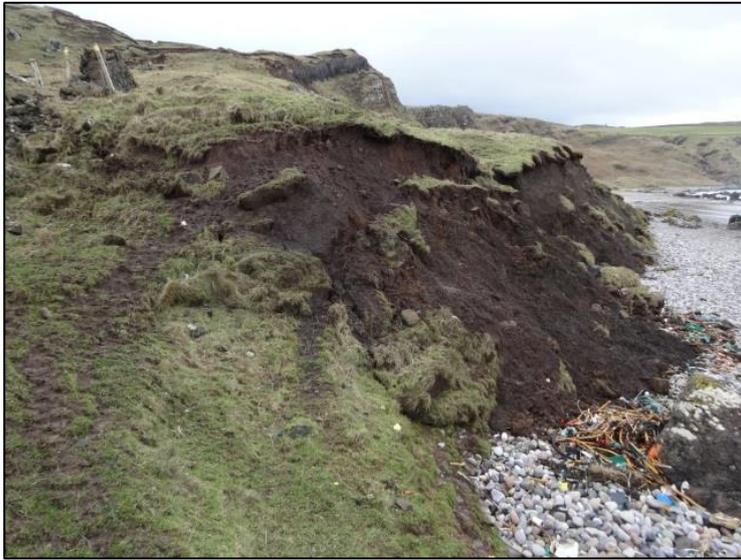
2. Immediately above the pebble beach, a cross section through part of the landslide's toe is revealed (Figure 10) exposing highly weathered loose gravel of CPV-BAROCM (Figure 11, which is unlike the debris near the main scarp (Figure 5d) - which is composed of sandy clay with large angular boulders of basalt.

**Figure 10:** Toe of recent landslide, exposed on the coast. Note displaced grass and strandline and recent beach deposits buried by landslide debris. Photo facing south.

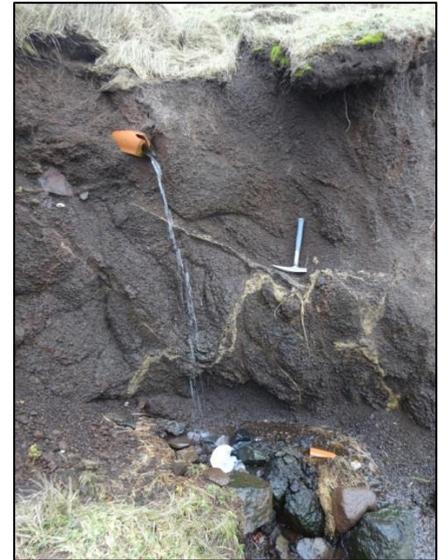
**Figure 11:** Detail of in-situ, weathered basalt (CPV-BAROCM), with wavy grey bands of highly weathered bedrock. This deposit is gravelly and very friable. Photo facing south east.

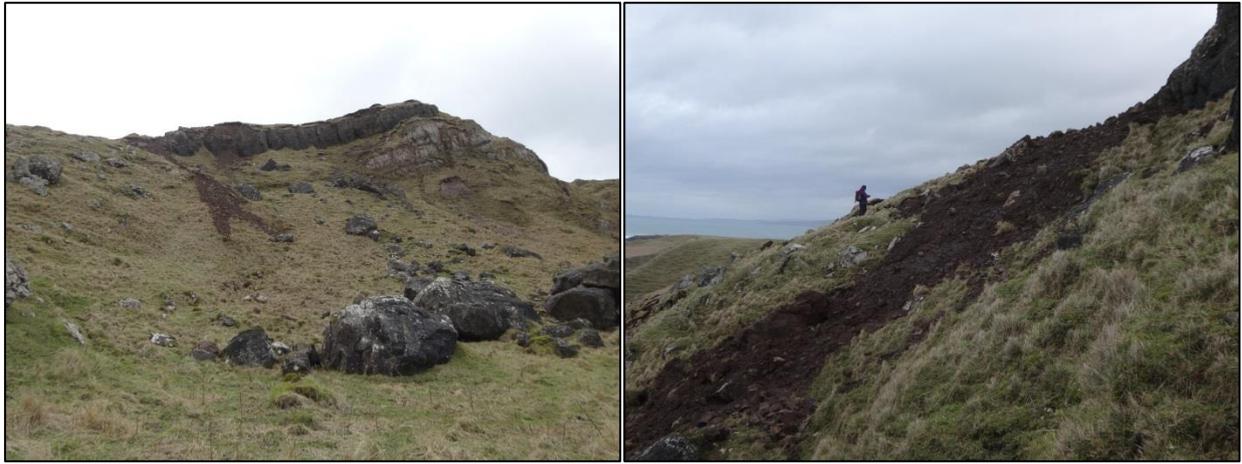
Where the landslide mass adjoins the cliffs to the south, a smaller boulder rich debris flow has occurred depositing debris. This flow occurred as landslide material slid to the north-west, meeting the cliff edge, before flowing down the steep slope below the cliffs (see Figure 12).

**Figure 12:** Left - view from the beach facing eastward. The mud flow is visible coming down the slope to the left of the lines of cliffs. The line of large boulders marks the down slope extent of several previous flows. Right - extent of debris flow material derived from the main landslide mass that has escaped over the coastal slope. Photo facing north east.
