The 2017 Regent Landslide, Freetown Peninsula, Sierra Leone

Quarterly Journal of Engineering Geology and Hydrogeology: Keeping Lessons Alive
Thematic Set

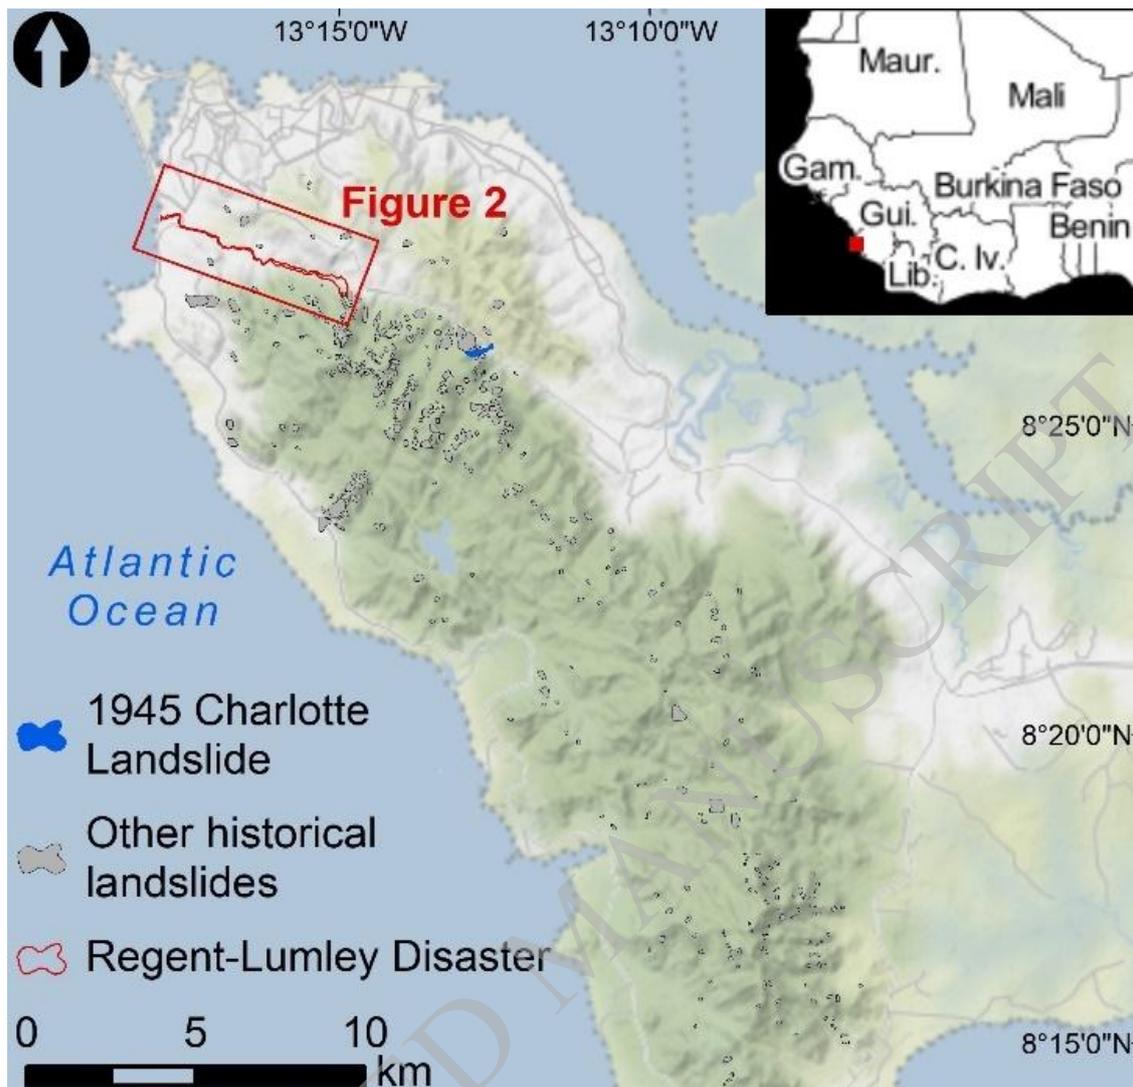
Figure 1: The Freetown Peninsula, showing historical landslide scars (Thomas, 1998, his unpublished work and updated by BGS in 2017 – Arup et al., 2018) and the 2017 Regent-Lumley Disaster. Basemap by Stamen Design, under CC BY 3.0. Data by OpenStreetMap, under CC BY SA. Inset map shows the location of Freetown (as a red dot) in West Africa.

reflective surface. In the 1970s and 1980s M. Thomas mapped several hundred slide scars (Figure 1) in the central highlands from 1:12,500 scale aerial photo interpretation with some field observations to ground truth remote assessments (Thomas, 1998).

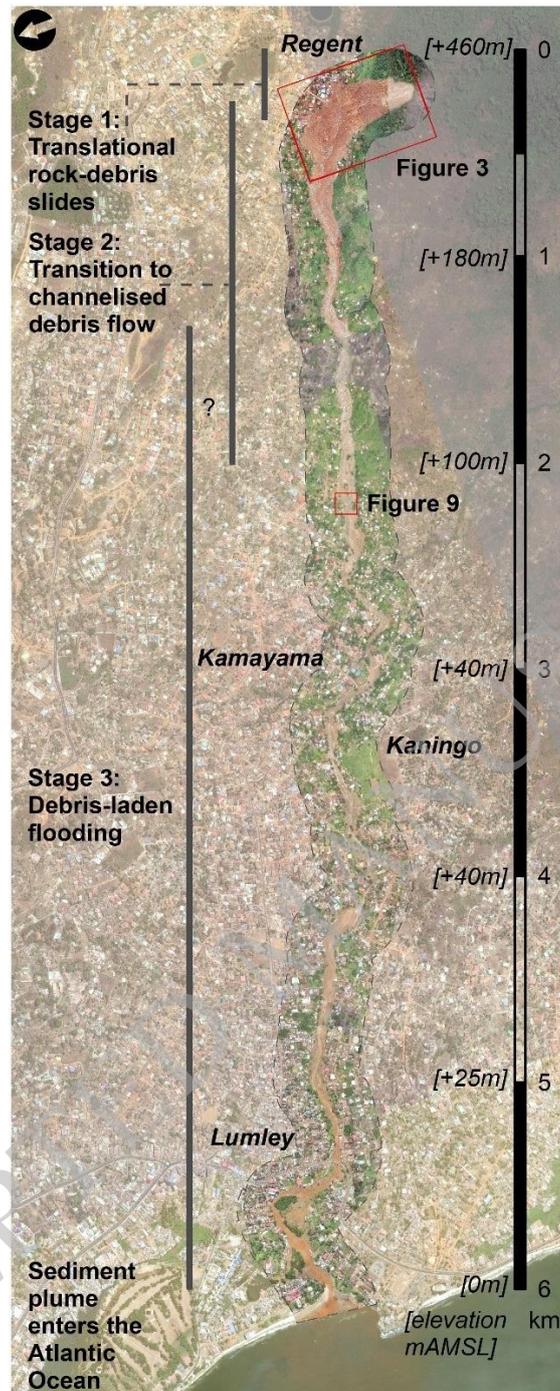
Figure 2: The Regent-Lumley Disaster between along the Babadorie Valley. Imagery shown with a hatched outline of the Regent-Lumley Disaster (centre) by EDA for the World Bank (30th August 2017) and by TYB for UNOPS (24th May 2018). Background imagery by DigitalGlobe (main image 3rd March 2017 imagery, sediment plume shown from 15th August 2017 imagery), under CC Attribution-NonCommercial 4.0 International (<https://creativecommons.org/licenses/by-nc/4.0/legalcode>).

The following presents a summary of the sequence of events which led to and included the Regent Landslide. The interpretation of events is compiled from eyewitness accounts, photographs taken immediately following the disaster, aerial photography, satellite imagery, and engineering geological and geomorphological fieldwork carried out between August 2017 and April 2018 by Arup and the British Geological Survey (BGS) for the World Bank and United National Office for Project Services (UNOPS). Figure 2 presents an overview of the 6 km long hazard footprint.

The destructive force of the debris flow would have gradually reduced from east to west as its load was deposited, the topographic gradient reduced, and the floodplain widened. By the time the debris flow reached Lumley, it would have resembled a large, relatively fast flowing flood (compared to what might be a typical seasonal flood in the channel). The floodwaters then flowed out into the Atlantic Ocean, depositing their remaining load as a sediment plume, which can be clearly seen in post-event satellite imagery (Figure 2).

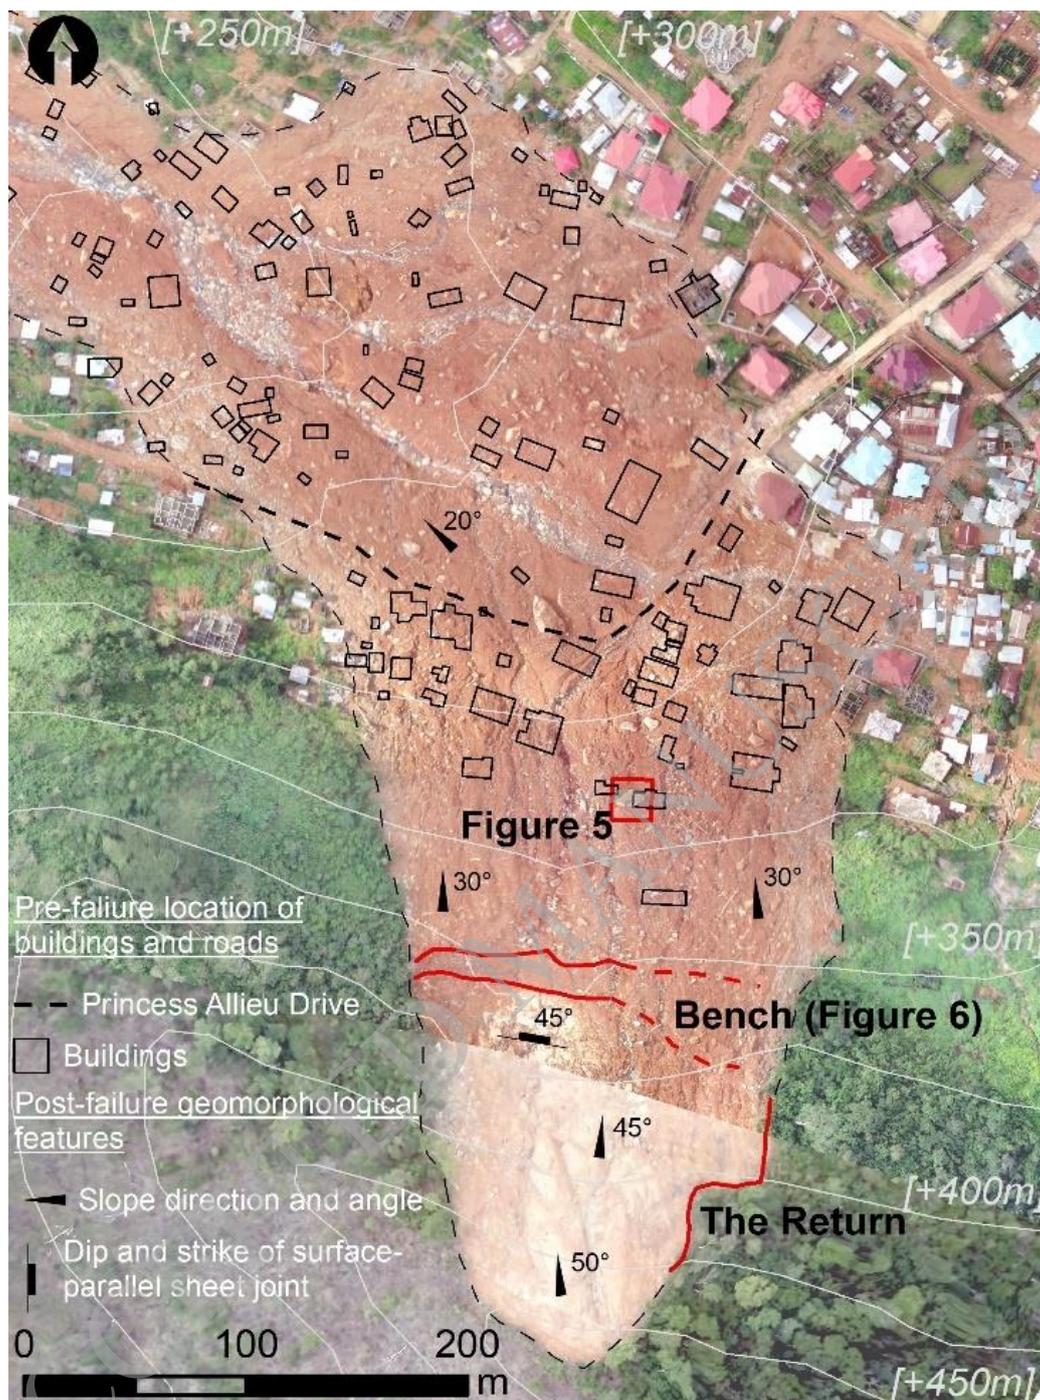
Figure 3: The Regent Landslide (shown hatched black). Imagery by EDA for the World Bank (30th August 2017) and by TYB for UNOPS (24th May 2018).

The Regent Landslide initiated on a north-north easterly facing slope, at approximately 06:50 on Monday 14th August 2017 (Figure 3). During post-failure inspection water seepages were observed draining from open joints on the upper parts of the landslide scar. The compound effect of softening of clay-infill within discontinuities, loss of pore suctions due to saturation under an extreme rainfall event, and increased pore-water pressures on key joint sets within the gabbro rock mass are considered to be key factors which led the slope to fail. The landslide is understood to have occurred in two phases, as indicated by eyewitness accounts.

cover is present on the adjacent hillslope. This area is referred to as 'The Return' (marked on Figure 3 and Figure 4).

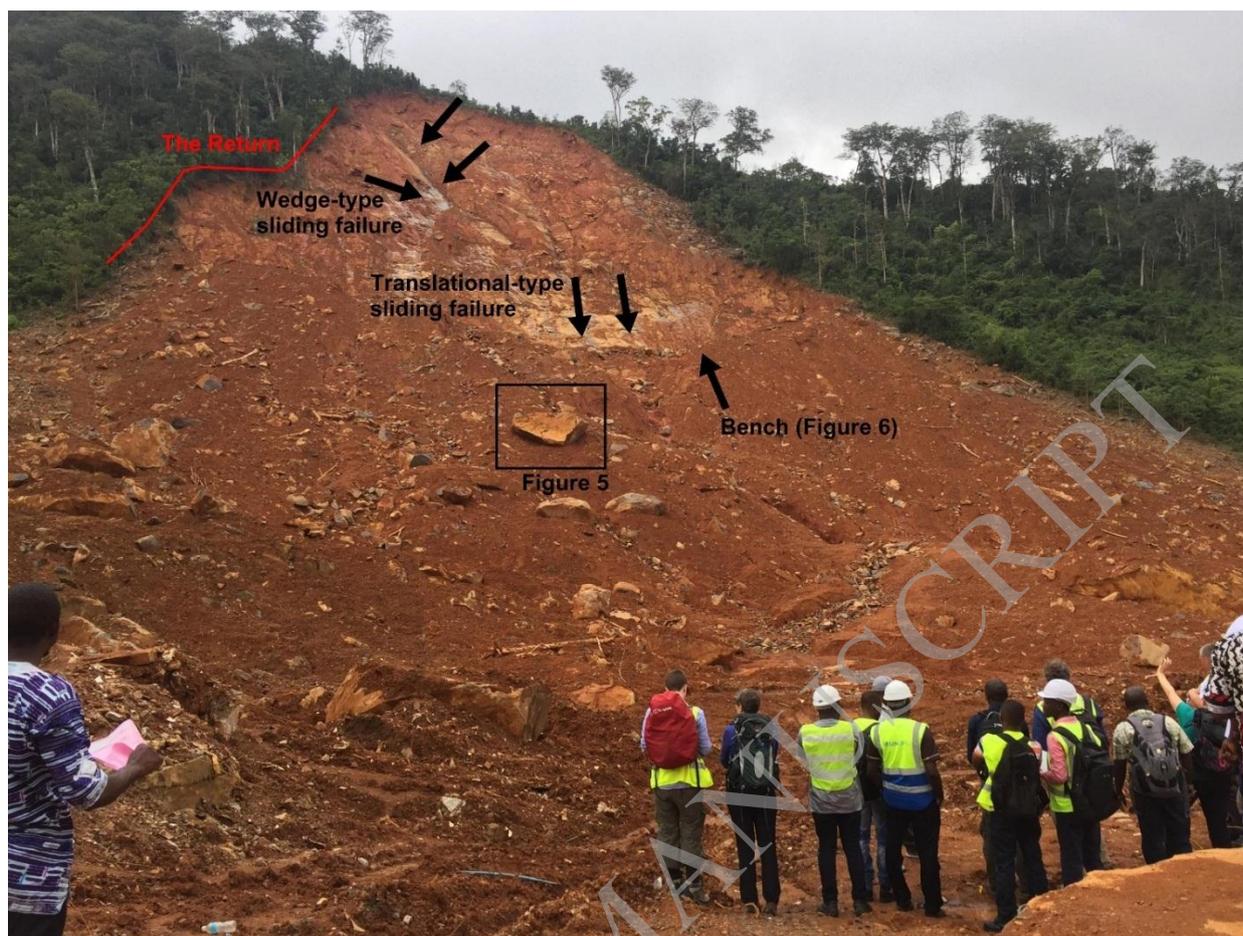
Figure 4: The Regent Landslide formed a large ~250 m wide ~200 m tall scar on the landscape on the north-facing side of a mountainous valley in Regent, Western Area Rural, Freetown (view looking south, image by Arup, 24th August 2017).

Two clear failure mechanisms can be identified from the upper part of the landslide scar (Figure 4):

(A) In the upper scar area, the fracture orientation facilitated wedge-type sliding failure mechanisms (recognised in the immediate aftermath of the landslide by Usamah, 2017), along weathered joints within the gabbro, which released large angular blocks of variously-weathered gabbro (Figure 5);

(B) On the lower part of the upper scar the joint pattern is different, with highly persistent and broadly undulating slope-parallel sheet jointing lined with softened clay infill within partially-weathered gabbro being the principal discontinuity set, favouring a more planar translational sliding mechanism.

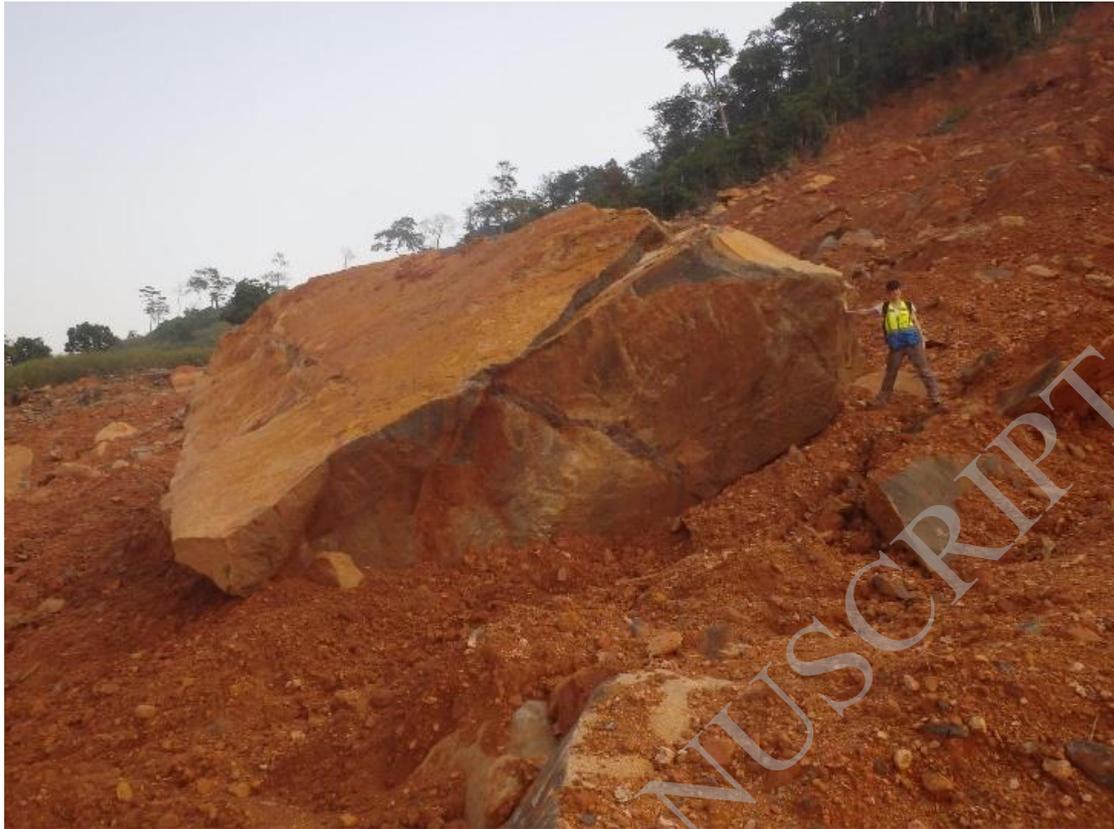
Figure 5: The first stage rock slide processes released angular blocks of gabbro depositing boulders up to 15 m long. (image by Arup, 10th December 2017).

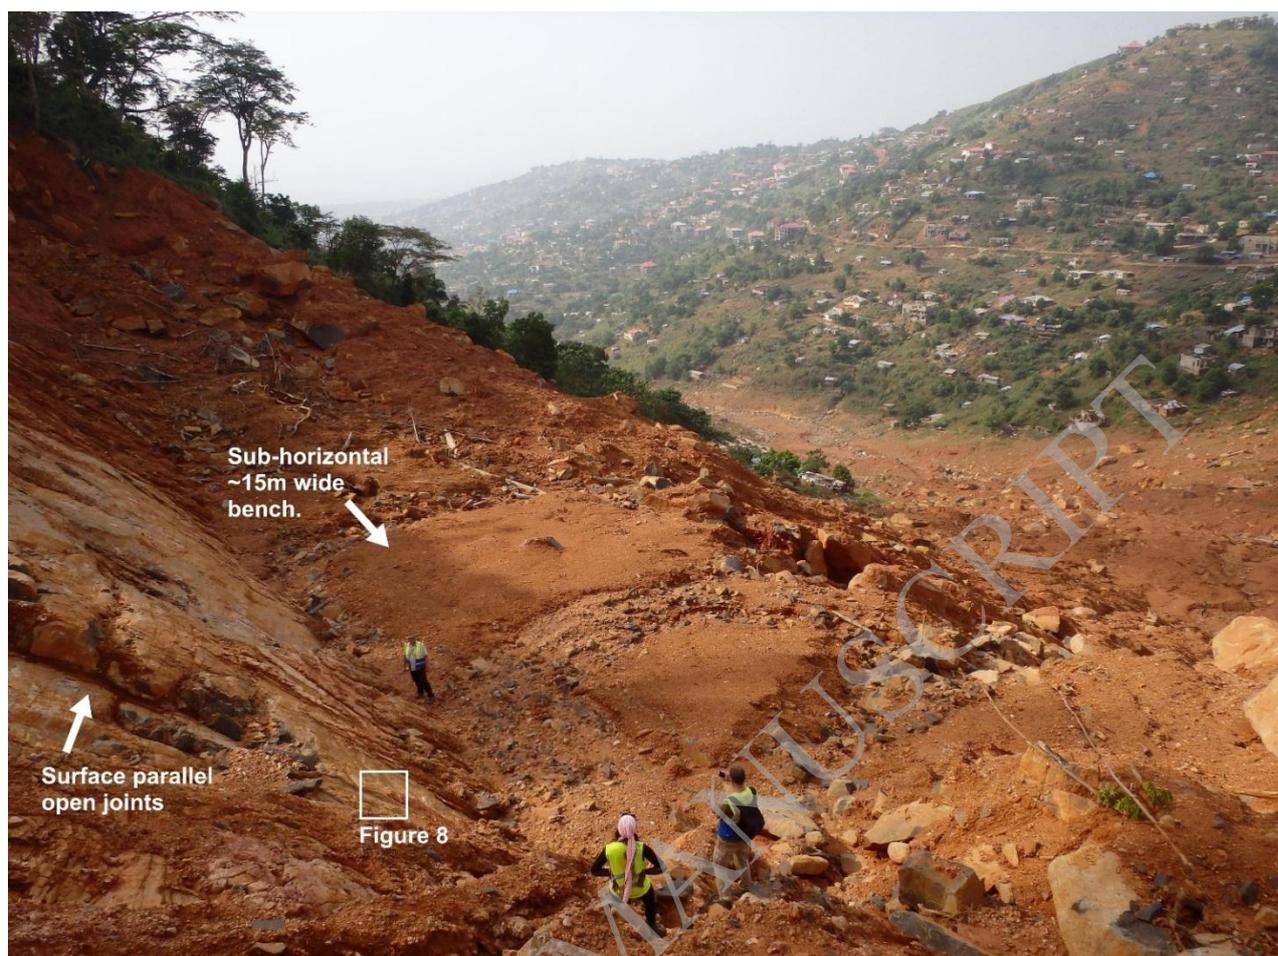
Figure 6: The morphology of the slope features an upper bedrock scar exposing weathered steeply dipping persistent undulating sheet-joints and a flat bench on the mid-slope (centre image), where the deep-seated basal slide surface probably emerged. The lower slope is covered by colluvium with large boulders. All slope vegetation was stripped away and most buildings destroyed (view looking west, image by Arup, 10th December 2017).

The discovery of in situ remains of a house foundation in the mid-slope area, below a prominent bench feature located at approximately 350 mAMS (Figure 6) points to a slope failure contained entirely within the upper slope area, and rules out a basal or toe failure. Quite why the failure broke out at mid-slope and formed a bench feature rather than continuing to some deeper level remains unclear. Broad ~10 m wavelength undulations with an amplitude of ~1 m along the controlling surface-parallel gabbro sheet joints may have brought the failure plane closer to the ground surface here, causing it to daylight in the slope. The debris then ran out and stripped off the slope vegetation and topsoils from the lower slope but did not fail through it (Figure 7).

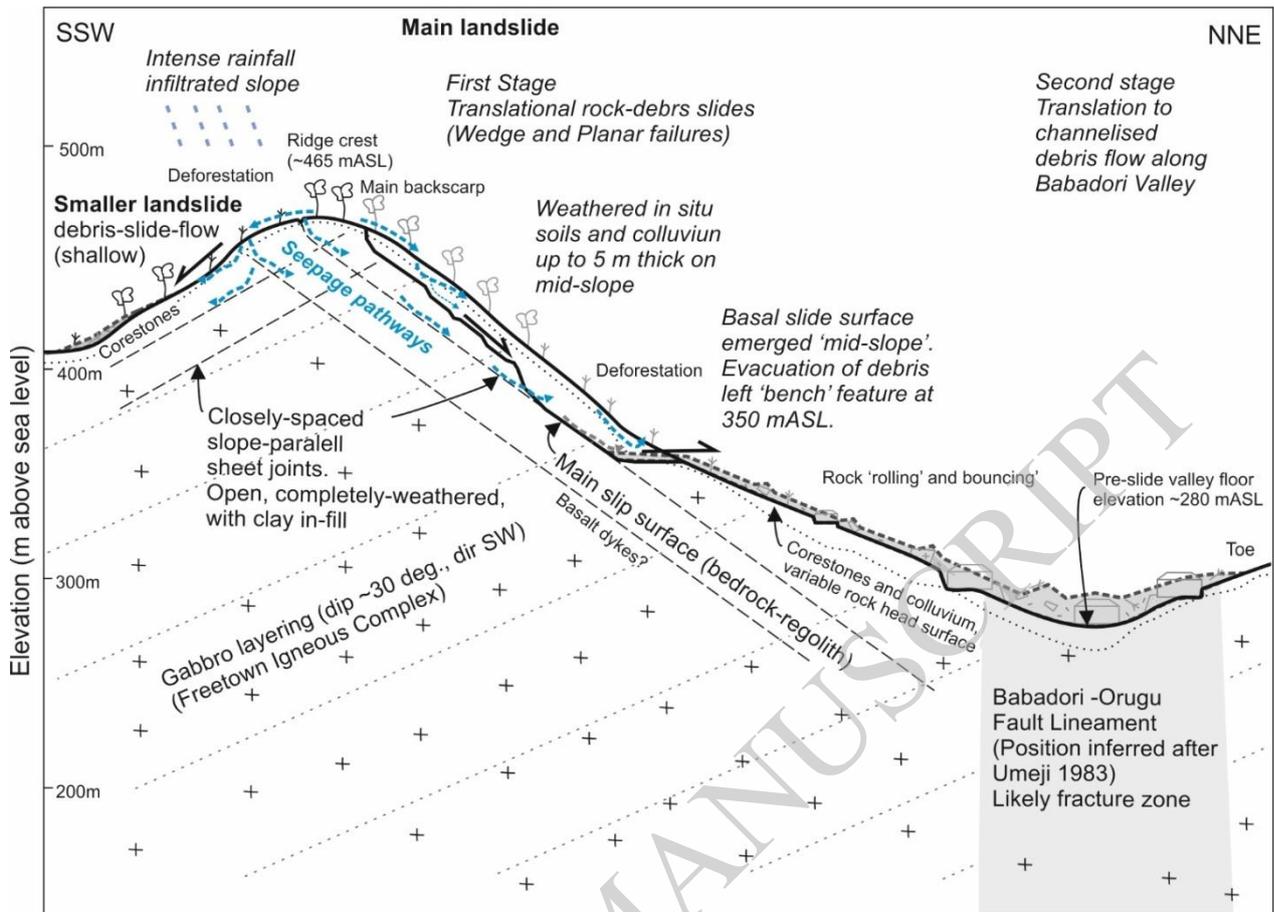
Figure 7: Schematic cross section showing main tectonic, geological and geomorphological features.

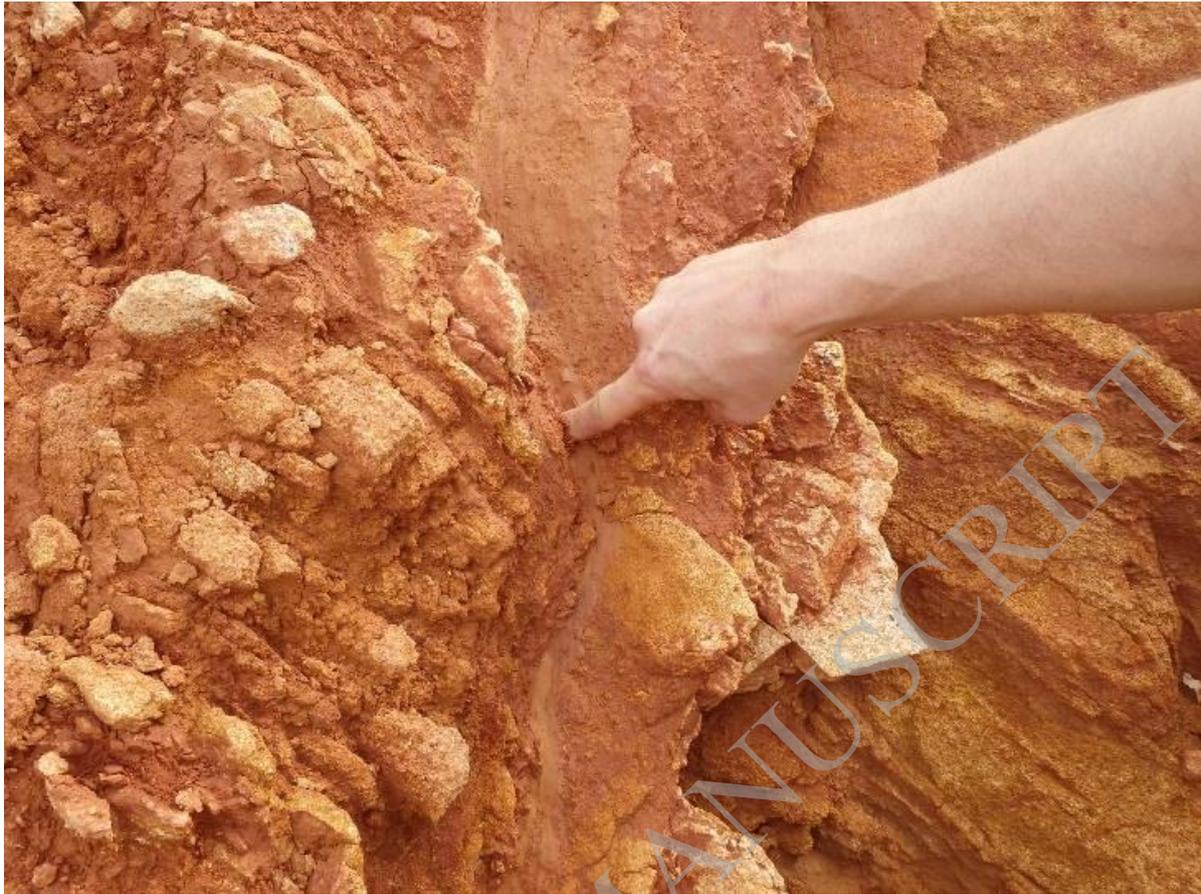
Figure 8: Surface parallel joints located 5-10 m below the pre-slide ground surface (now exposed by the Regent Landslide) are filled with clay (image by Arup, 10th December 2017).

The identification of clay filled fractures in the gabbro host rock is highly significant to slope stability and ground engineering projects on the Freetown Peninsula, due to the marked reduction in shear strength and rock mass strength these features introduce. Local sources suggest the nearby Sugar Loaf Mountain gets its name from a colloquial understanding of this problematic geotechnical behaviour, whereby hard granular soils rapidly disintegrate to a 'syrup-like slurry' on wetting.

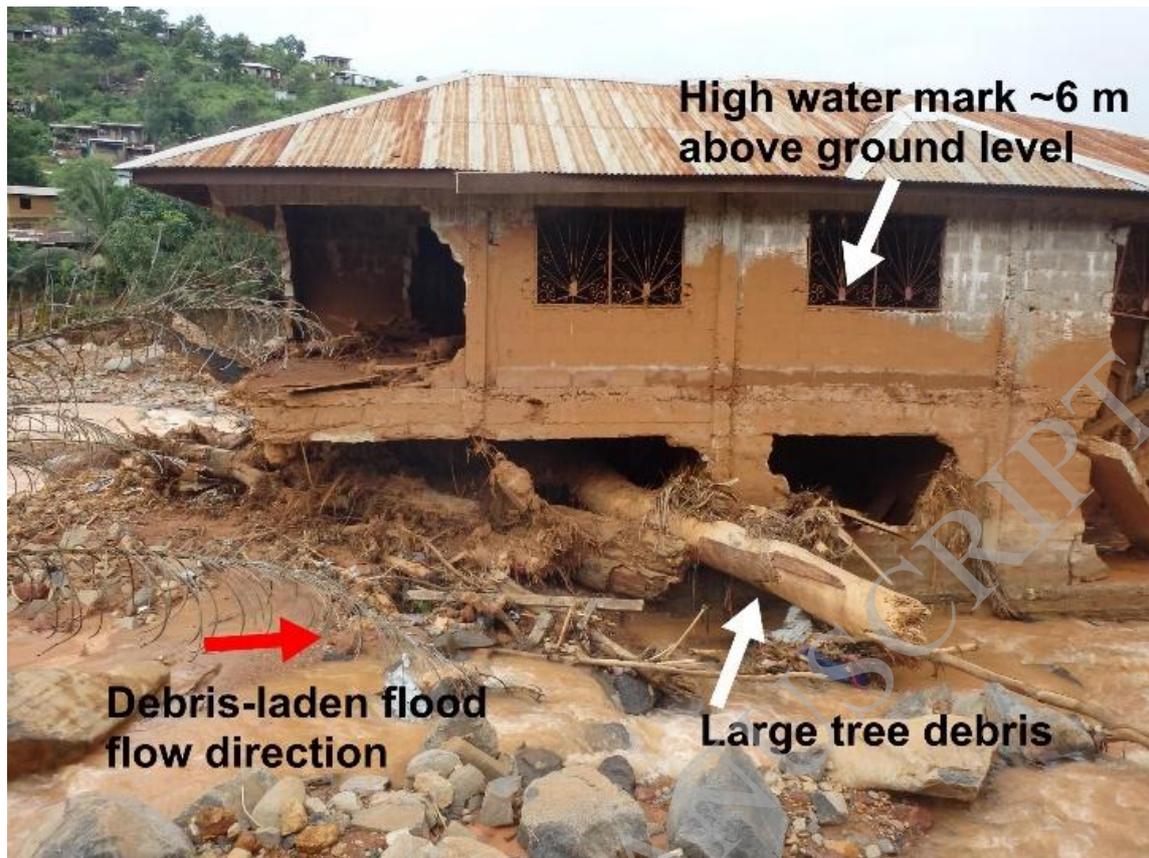
Figure 9: Damage to buildings resulting from the second stage debris-flow and third stage debris-laden flooding was significant. This image shows a property destroyed by debris carried by the flood in Kamayama, ~3 km downstream from the site of the Regent Landslide (image by Arup, 25th August 2017).

The impacts of the disaster varied along the length of the Babadorie Valley. In Regent, despite larger and apparently more structurally robust buildings, the number of fatalities and proportion of buildings destroyed was highest. This can be attributed to the devastating high-energy nature of the landslide which affected this area. To the west, although further from the source of the landslide, damage to properties in the channel near Kamayama was still extensive (Figure 9), which demonstrates the debris-laden nature of the flooding here. In

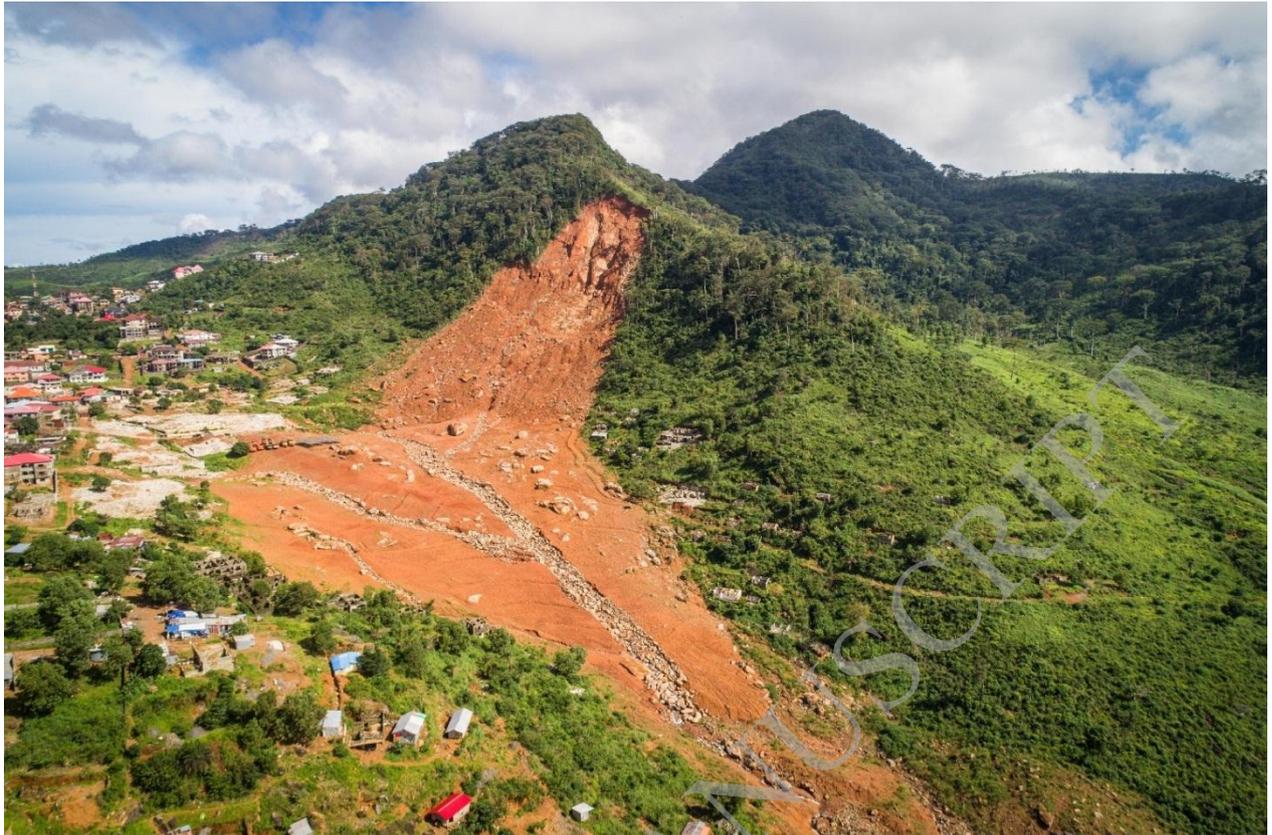
Figure 10: Oblique aerial photograph of the Regent Landslide in 2018 after partial completion of rehabilitation works, improvement of drainage and replanting in the toe area of the Regent Landslide (image by TYB for UNOPS, 8th October 2018).

Rehabilitation works at the site of the Regent Landslide have been ongoing since April 2018 and have largely comprised the regrading and management of the slopes and watercourses at the foot of the Regent Landslide in Regent (Figure 10). Moving forward, landslide risk in this area will be managed by reducing exposure by preventing rebuilding and resettlement in the Babadorie Valley, much of which, including the affected areas in Regent, is already designated as a National Forest Reserve. Managing risk by more traditional hard-engineering approaches which typically seek to reduce hazard (by rock-bolting or netting etc.) was not appropriate given the urgent need to implement risk reduction measures at the site prior to the 2018 rainy season and other logistical and financial considerations. The site has also been much re-planted which will act to both deter resettlement and promote the local stability of the reprofiled channels. Much of this rehabilitation work and replanting was done by the local population, many of whom were affected by the disaster.
