# Coastal landslide monitoring at Aldbrough, East Riding of Yorkshire, UK

**Abstract:** The paper describes results to date of a continuing monitoring study of coastal ‘soft cliff’ recession at the British Geological Survey’s (BGS’s) Coastal Landslide Observatory (CLO) on the east coast of England at Aldbrough, East Riding of Yorkshire. The cliffed site, part of the 50 km long Holderness coast, consists of glacial deposits, and is one of the most rapidly eroding coastlines in Europe. This rapid rate of erosion provides an ideal opportunity for observation and process understanding because it facilitates the collection of data over periods of time encompassing significant new landslide events at the same location. The results of two approaches are reported: first, terrestrial Light Detection and Ranging (LiDAR) surveying (TLS); second, the installation of instrumented boreholes. The aim of the research is to combine these to investigate the role of landslides and their pre-conditioning factors and the influence of geology, geotechnics, topography and environmental factors on cliff recession. To date, an average recession rate of 1.8 m a<sup>-1</sup> and a maximum rate of 3.4 m a<su

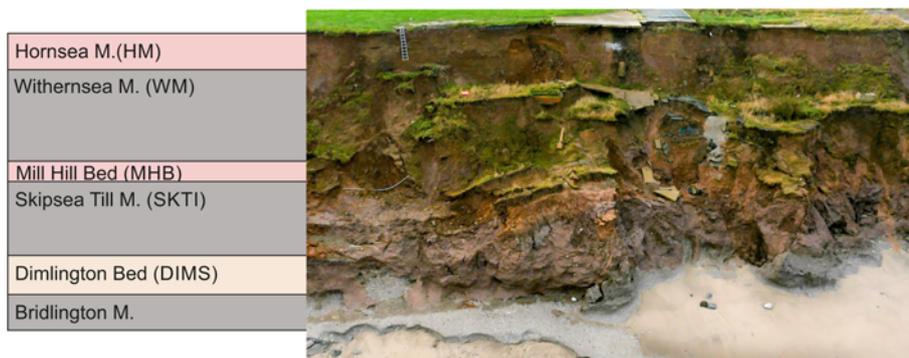
**Fig. 2.** Schematic stratigraphy with photograph of central (100 m) embayment (not to scale) (BGS©UKRI). M, Member.

The lithostratigraphy at the site is summarized in Figure 2; a fuller description has been provided by Hobbs *et al.* (2019). From an engineering geology viewpoint the major till units, belonging to the Withernsea, Skipsea Till and Bridlington Members of the Holderness Formation, represent fissured, lightly to heavily over-consolidated materials having similar geotechnical properties that are in general agreement with descriptions by Bell & Forster (1991), Bell (2002) and Powell & Butcher (2003). However, the laminated, silty, clayey (and glactectonized) Dimlington Bed between the Skipsea Till and Bridlington members, at around 15 m depth, combines low strength and high average permeability with high plasticity and compressibility. Evidence from exposure on the cliff, when compared with the borehole logs, suggests that the Dimlington Bed is prone to liquefaction and may have undergone

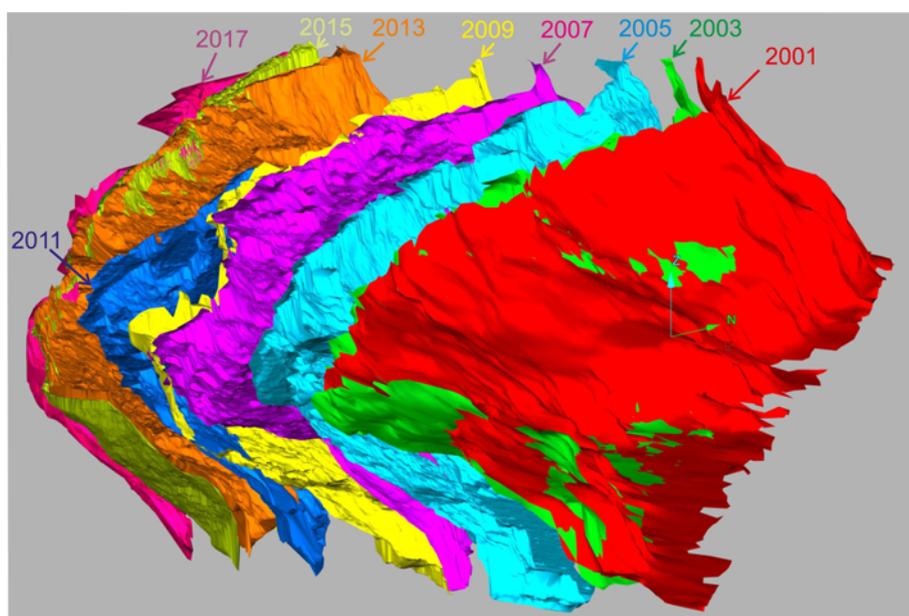
**Fig. 3.** Selected biennial digital elevation models (DEMs) for CLO cliff (central embayment) (BGS©UKRI). Intermediate DEMs are omitted for clarity. Width of DEM is 100 m.

Since 2001, cliff monitoring has been maintained at the Aldbrough test site using Terrestrial LiDAR Surveying (TLS) (Hobbs *et al.* 2002, 2013, 2015a; Poulton *et al.* 2006; Miller *et al.* 2007; Buckley *et al.* 2008), more recently augmented by unmanned aerial vehicle (drone) photogrammetry. The data from the TLS are used to construct digital elevation models (DEMs), examples of which are shown in Figure 3. These were compared and used to characterize landslide processes and to calculate volume changes between surveys. Up to November 2017, 38 surveys had been carried out at Aldbrough, 27 of which have been used in volume calculations. The data obtained from the monitoring surveys have allowed geomorphological assessments and multiple cross-sections for slope stability analyses to be derived. Volumes lost from the cliff have been calculated directly from the TLS models for the period September 2001 to November 2017 (Table 1; Fig. 4), these representing a potentially useful calibration dataset for coastal process modelling (Pethick 1996; Walkden & Dickson 2008). The data shown have been extracted from the central 100 m of the study site retreating along the line of recorded migration of the central embayment.

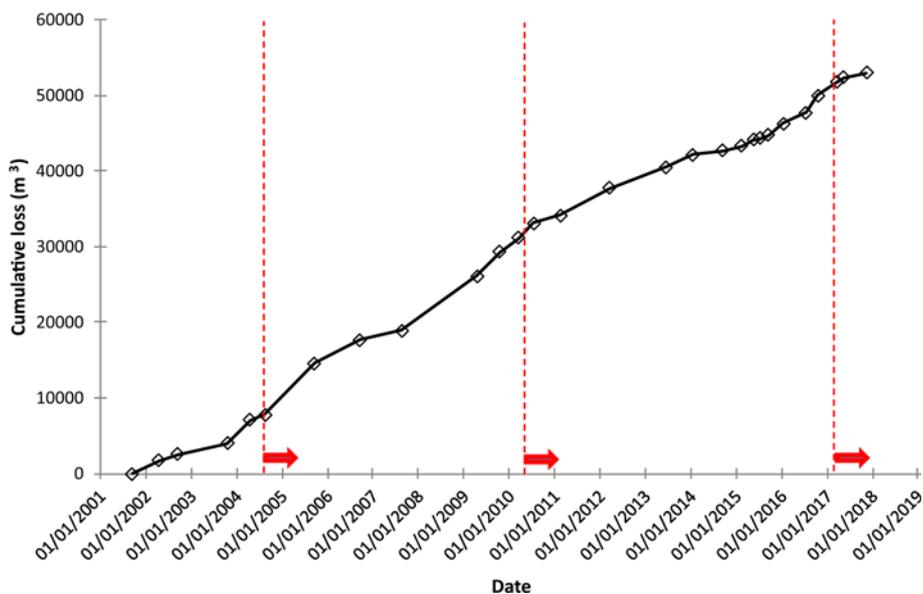
Fig. 4. Plot of date v. cumulative volume loss from cliff (per 100 m) at CLO (September 2001 datum) (BGS©UKRI). Dates of major fresh landslide events in central embayment are shown as dashed red lines with arrows.

The monitoring has shown that the cycle of major landslide events at the CLO is every 6–7 years, this being based on three events identified since September 2001 (i.e. August 2004, March

2010 and February 2017; Figs 4 and 7). This compares with a cycle of around 30–40 years for the 40 m high London Clay cliffs at Warden Point, Isle of Sheppey, Kent (Dixon & Bromhead 2002). As was the case at Warden Point, the embayments at the CLO have retreated along the same heading (due west in this case) and maintained their dimensions over the monitoring period. This is at odds with the suggestion of Pethick (1996) that embayments migrated southward at Holderness. Pickwell (1878) observed 3–4 year cycles of landslide activity at Tunstall (10 km SSE of Aldbrough).

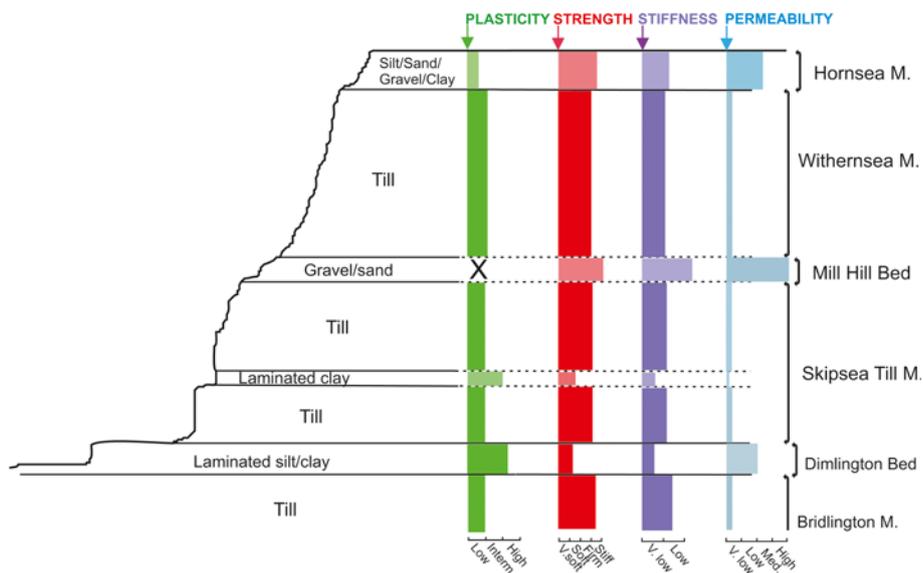
Fig. 5. Conceptual geological-geotechnical model for the CLO. (BGS©UKRI).

The conceptual geological–geotechnical model for the CLO is shown in Figure 5. This has been derived from data described by Hobbs *et al.* (2019).

The primary type of landsliding at the CLO is observed to be deep-seated rotational. These landslides daylight 1–3 m above the cliff toe, a position largely determined by the undulating boundary between the Bridlington Member and the Dimlington Bed. This compares with a deeper-seated landslide at nearby Cowden cliff

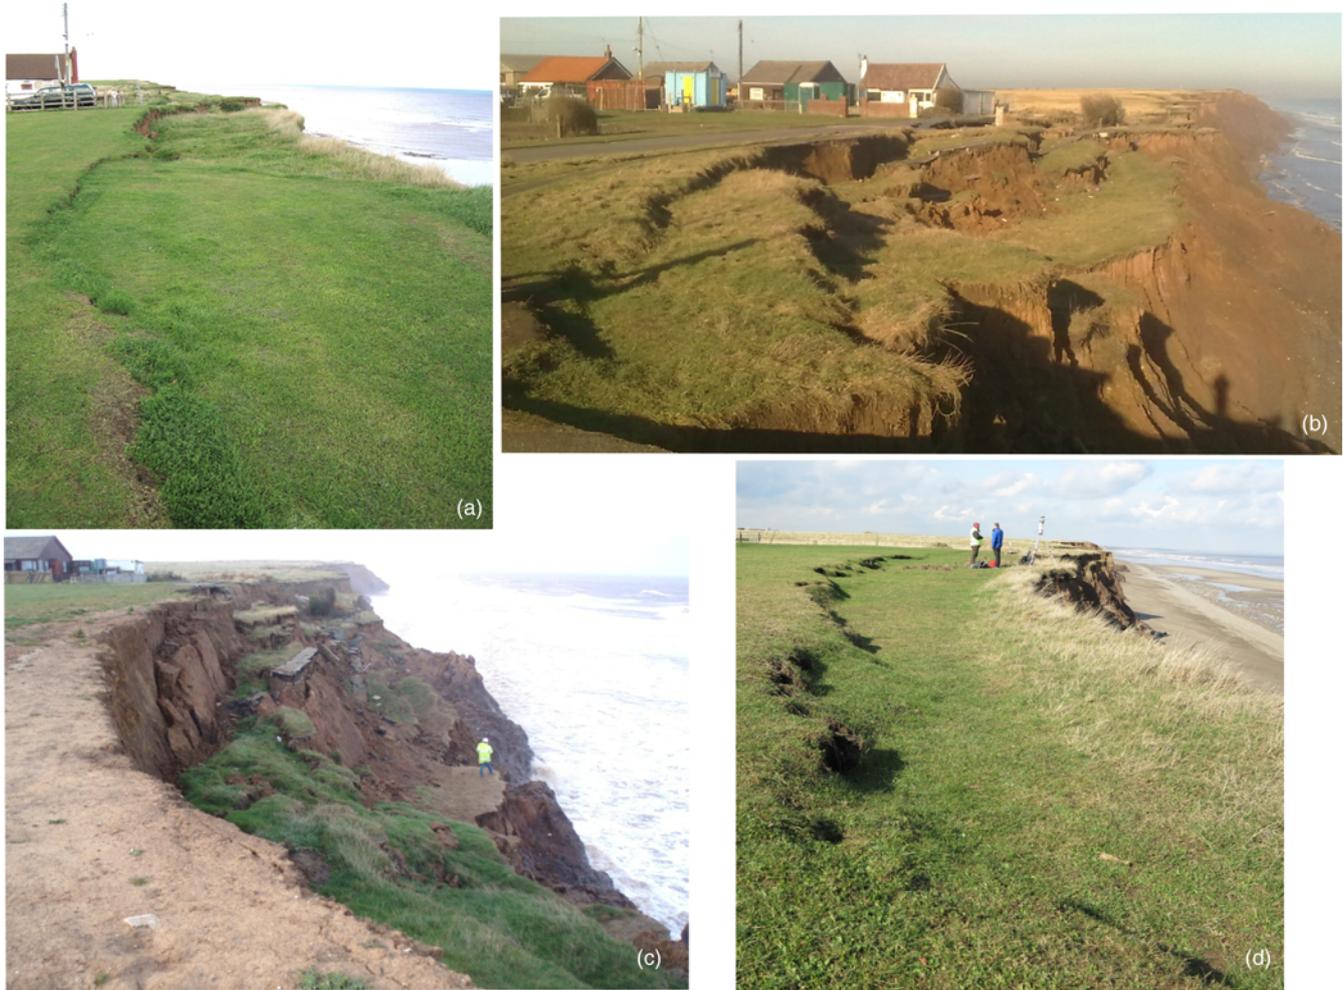
**Fig. 6.** Examples of different stages of deep-seated rotational landsliding in the central embayment of the CLO: (a) August 2004; (b) February 2011; (c) November 2011; (d) November 2017. All cliff access was carried out with a full risk assessment (BGS©UKRI).

Secondary landslides tend to occur within the slipped mass (Fig. 6b and c), although toppling of Withernsea Member blocks (typical volume 3–5 m<sup>3</sup>) also occurs from the over-steepened promontories separating embayments. Toppling has also featured, but on a much larger scale, at Warden Point (Dixon & Bromhead

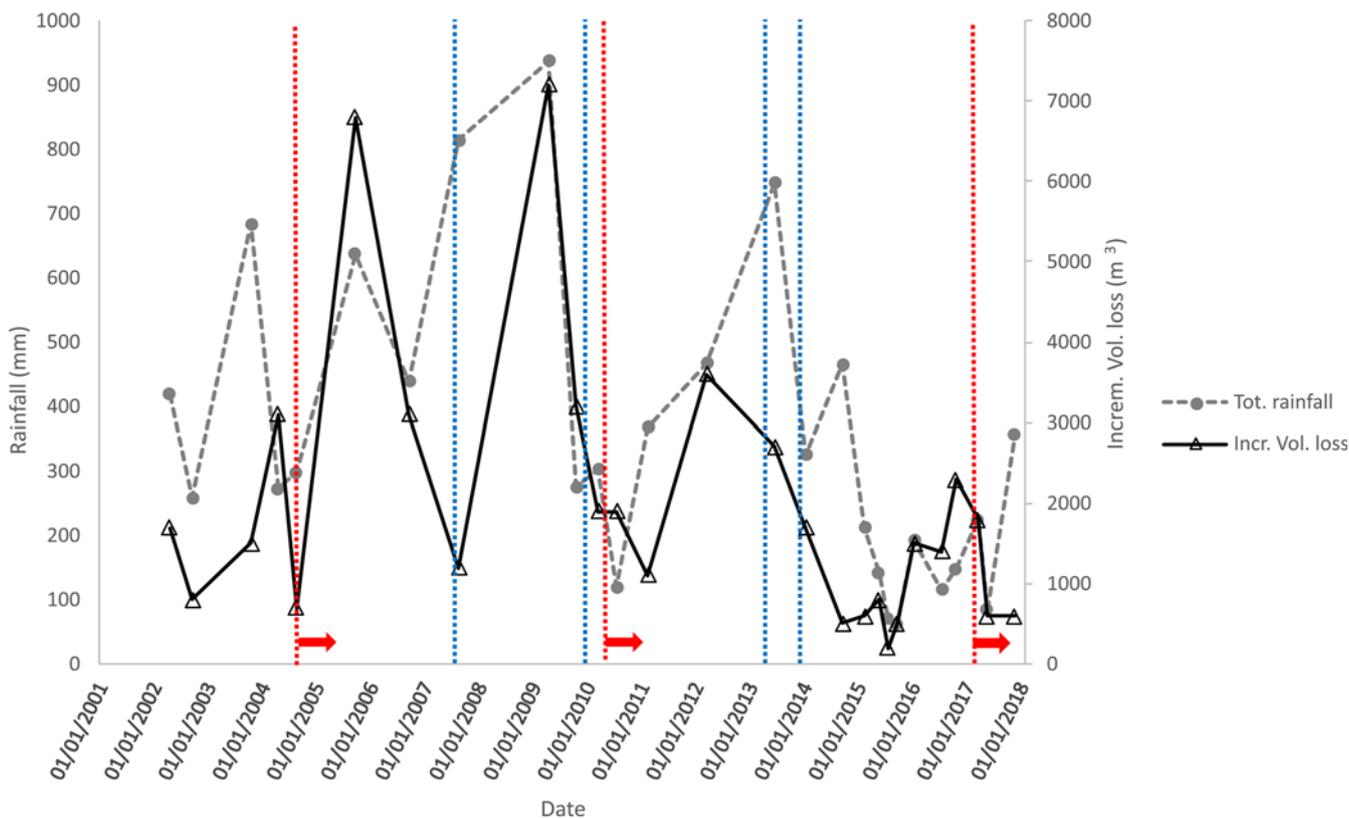
**Fig. 7.** Plot of date v. total rainfall and incremental volume loss (per 100 m) from cliff. Includes Met Office data (2001–2011) (BGS©UKRI). ‘Total rainfall’ refers to total rainfall since last survey. Dates of major fresh landslide events in central embayment are shown by dotted red lines with arrows; notable storms are shown by dotted blue lines.

The relationship between incremental volume loss and total rainfall is also shown in Figure 7 (total rainfall refers to that since the previous survey). This shows a broad-scale agreement between rainfall and volume loss from the cliff (calculated from TLS) with peaks in volume loss following the major landslide events. (It should be noted that pre-2012 rainfall data are averages taken from three East Riding of Yorkshire stations within a 23 km radius of the CLO.)

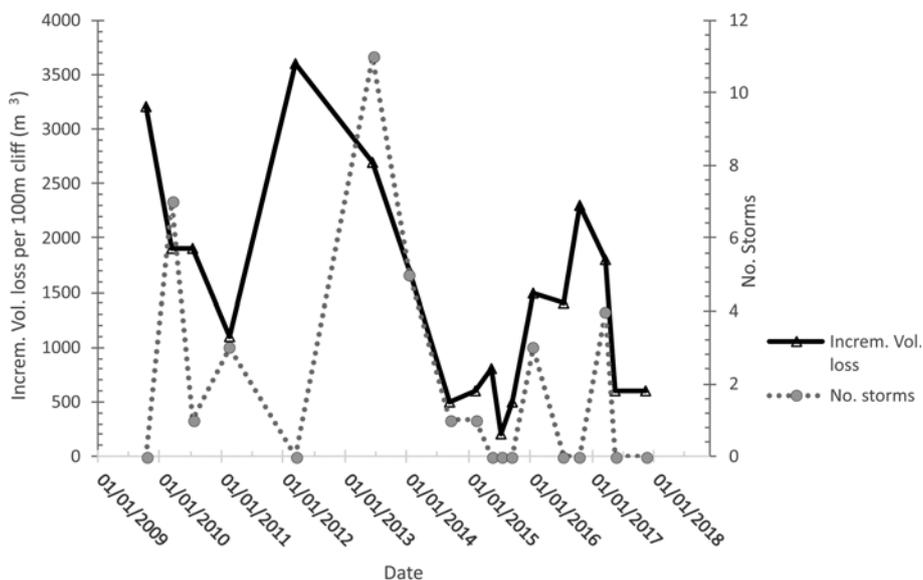
**Fig. 8.** Plot of date v. incremental volume loss from cliff (per 100 m) and number of storms since last survey (Hornsea buoy) ERYRCMP (1995). Includes data from CCO (BGS©UKRI).

The occurrence of storms, as defined by CCO (2017) and recorded at the Hornsea buoy from 2009, is plotted against incremental volume loss for 100 m of cliff (calculated from TLS) in Figure 8. It should be noted that a storm event is indicated using the ‘peaks-over-threshold’ method (CCO 2017) where the ‘wave height threshold’ was variously defined over the monitoring period from 3.00 to 3.75 m and based on 0.25 year return periods. A comparable long-term trend is shown but the number of storms does not appear to have a causal effect on cliff volume change. However, a closer agreement is evident after 2013 where TLS surveys are more frequent.

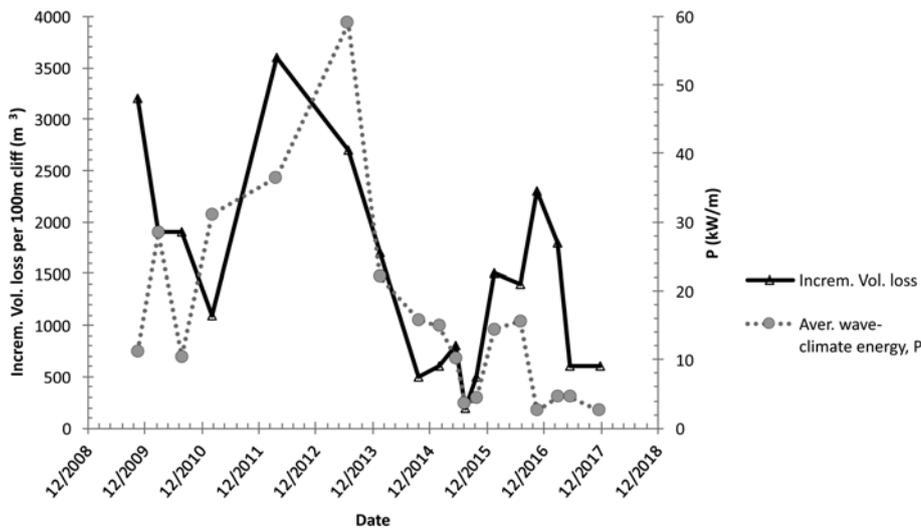
**Fig. 9.** Plot of date v. incremental volume loss from cliff (per 100 m) and average wave-climate energy (Hornsea buoy) ERYRCMP (1995). Includes data from CCO (BGS©UKRI).

A plot of average wave-climate energy *v.* incremental volume loss for 100 m of cliff (calculated from TLS) is shown in Figure 9; the wave data for which were provided by the Hornsea buoy (CCO 2017). The ‘wave-climate’ energy, *P* was calculated here as follows (Dexawave, <http://www.dexawave.com>):

The plot shows similar trends with time for cliff volume loss and wave energy, particularly when taken over several years. However, a causal effect is not indicated.

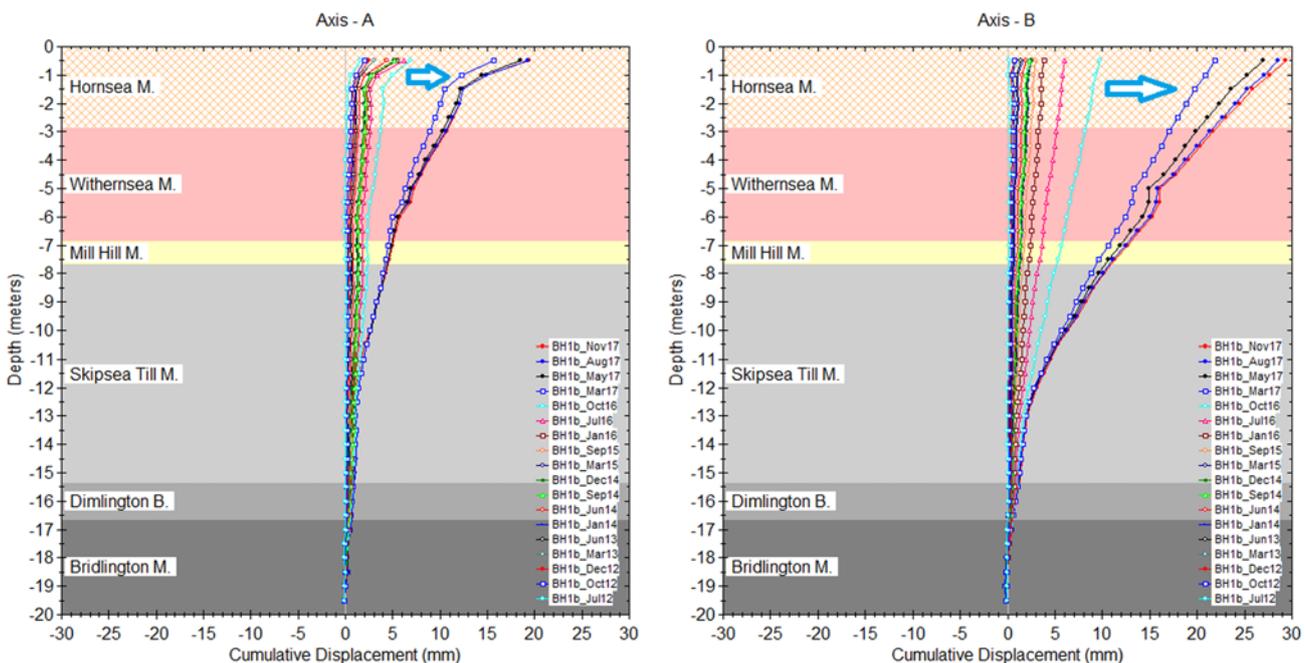
**Fig. 10.** Cumulative displacements for BH1b up to November 2017 (BGS©UKRI). Axis A is north; Axis B is east. July 2012 baseline. Blue arrows indicate pre-event displacements of winter 2016–2017.

The inclinometer results from Borehole 1b (up to August 2017) are shown in Figure 10 as cumulative lateral displacement, where the left-hand plot (Axis A) represents northward displacement and the right-hand plot (Axis B) eastward displacement. The scale on the x-axes (positive) is 0–30 mm (displacement) and on the y-axes is 0–20 m (depth). The plots show positive lateral

displacements from a depth of 17.5 m upward within the Bridlington Member, although significant displacements occur only above 12.5 m, within the Skipsea Till Member and overlying deposits, including the major one recorded between October 2016 and August 2017 and attributed to the landslide event of 14 February 2017. Displacements have consistently increased uphole in an overall linear trend, reaching a maximum eastward component (to August 2017) of 28 mm at a depth of 0.5 m in the Hornsea Member. Also, displacements have accumulated in a positive direction throughout. The equivalent maximum northerly displacement is 18 mm.

Prior to the event of February 2017 there has been a precursory (positive) trend starting between September 2015 and January 2016 and accelerating during 2016. This suggests a ‘lag’ of between 13 and 17 months on the B-axis (east) between initiation of perceptible accelerated movement and the landslide event itself, although the A-axis (north) movement has a shorter lag of between 4 and 7 months. It should be noted that this dataset has a July 2012 baseline.

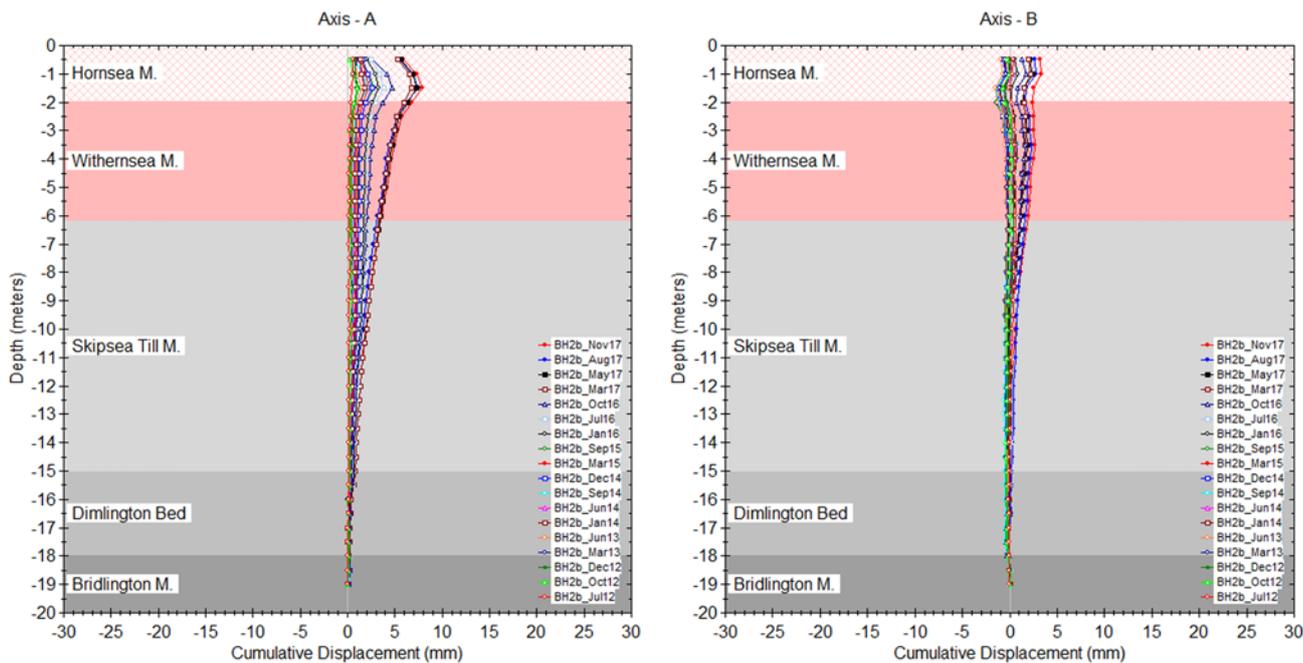
Fig. 11. Cumulative displacements for BH2b up to November 2017 (BGS©UKRI). Axis A is north; Axis B is east. April 2012 baseline.

Equivalent data for Borehole 2b (up to August 2017) are shown in Figure 11, to the same scale. Here displacements were greatly reduced compared with BH1b, a maximum cumulative northerly displacement of 7 mm having been reached at a depth of 1.5 m in the Hornsea Member. Lateral displacements occurred above a depth of 16 m and increased gradually uphole. It is noted that here the A-axis displacement, albeit small, exceeded that of the B-axis when compared with BH1b, possibly indicating some form of stress rotation. This dataset has an April 2012 baseline.

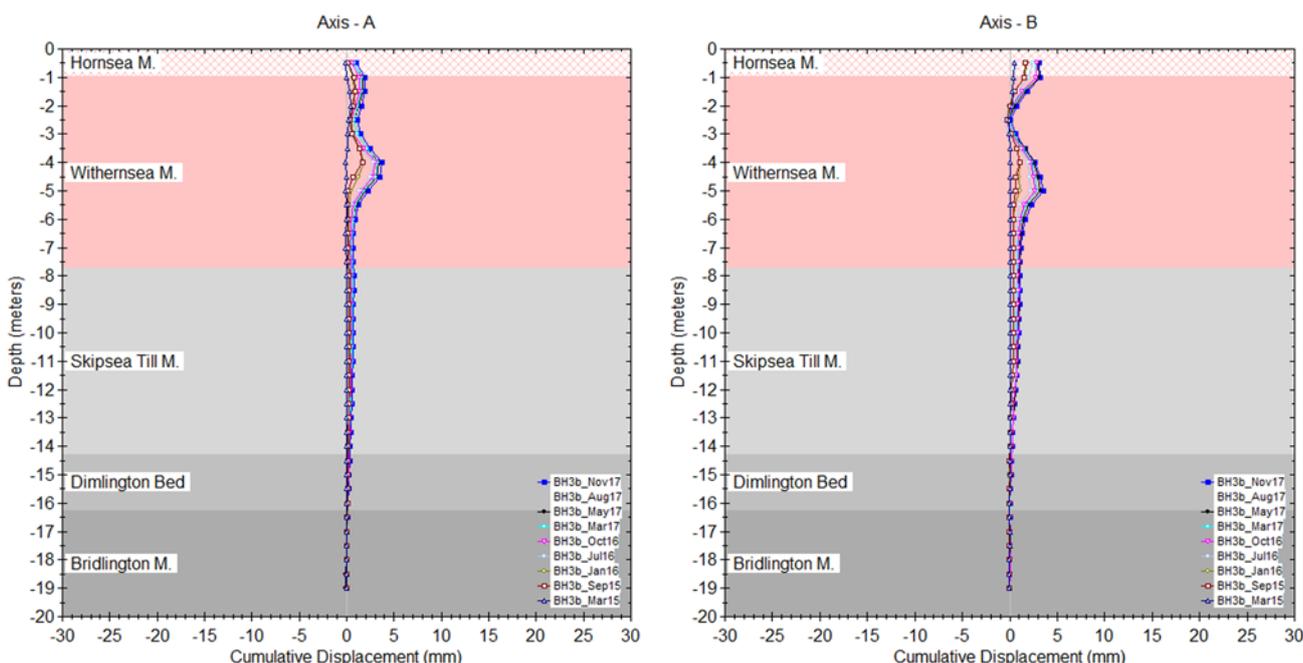
Fig. 12. Cumulative displacements for BH3b up to August 2017 (BGS©UKRI). Axis A is north; Axis B is east. March 2015 baseline.

Equivalent data, but over a shorter period, for Borehole 3b (up to August 2017) are shown in Figure 12, to the same scale. Here only very small displacements were seen, initiating above 13.5 m depth and peaking at 3 mm at a depth of 5.0 m within the Withersea

Member. Displacements on both axes were comparable in amount. This dataset has a March 2015 baseline.

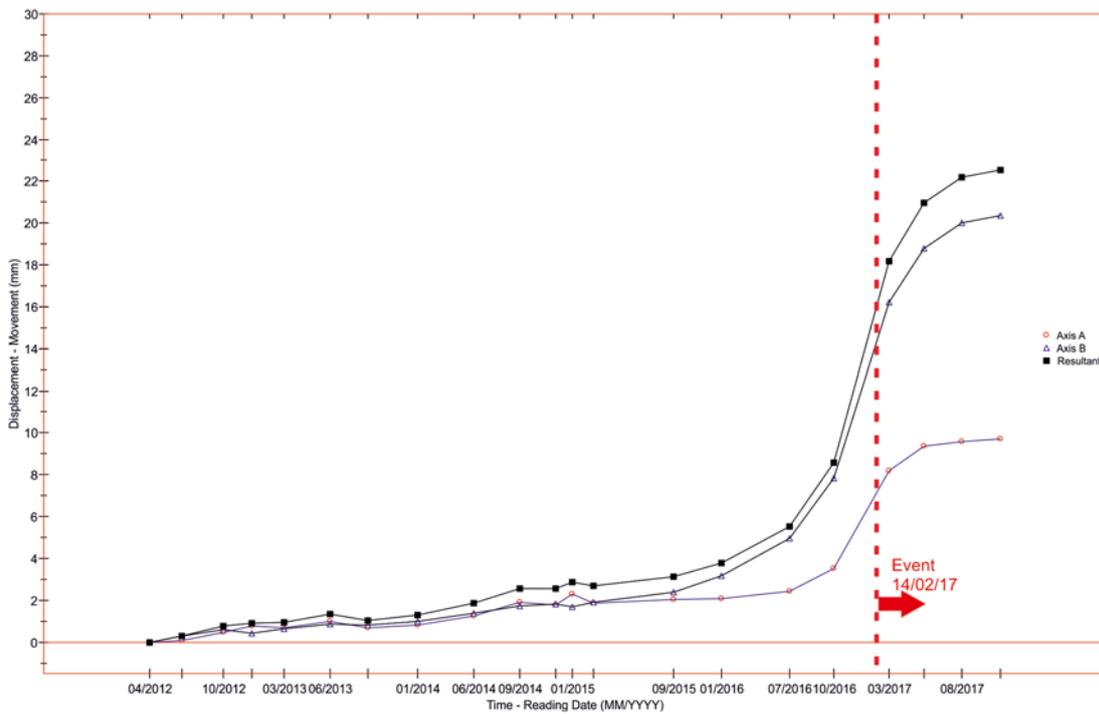
**Fig. 13.** Example plot of time v. displacement (cumulative) for BH1b inclinometer, 3.5 m depth (BGS©UKRI). Axis A is north; Axis B is east. April 2012 baseline. Dashed red line is landslide event.

An example of a ‘time’ plot (BH1a, 4 m depth) is shown in Figure 13. This sigmoidal curve clearly shows detection of the precursory build-up in displacement towards the cliff leading to the landslide event of 14 February 2017 and subsequent decrease in displacement after the event. This inclinometer, closest to the cliff, has thus ‘predicted’ the landslide event by more than a year. Results for other depths are similar, but reduce proportionately in magnitude to a depth of 12 m, below which there is no response to the landslide event (Fig. 10).

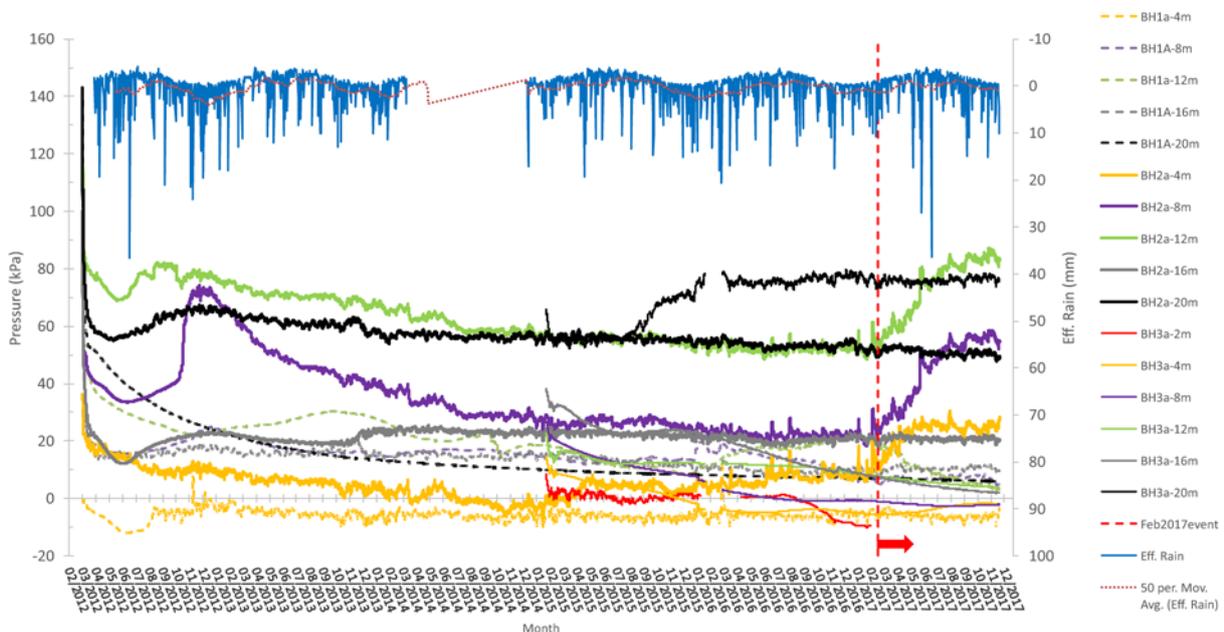
**Fig. 14.** ‘Time’ plot of month v. piezometric pressure and total effective daily rainfall (BHs 1a, 2a and 3a), April 2012 to November 2017 (BGS©UKRI). Landslide event (14 February 2017) is marked by red dashed line and arrow. Borehole 3a record starts February 2015.

Five fully grouted vibrating-wire piezometer sensors were installed in boreholes 1a and 2a and six in borehole 3a. The results are shown in the form of a 'time' plot (Fig. 14) of pore pressure readings at

Although pore pressure values tend to be low overall, the landslide event of February 2017 triggered distinct increases at the 4 m, 8 m and 12 m sensors in BH2a (Fig. 14). Somewhat unexpectedly, there was no response to this event in BH1a, which is closest to the cliff. This is currently unexplained, although loss of contact between sensors and formation is suspected, possibly owing to clay shrinkage and/or stress relief. There was also no response in BH3a, which is furthest from the cliff. With respect to effective rainfall (Fig. 14) there is no discernible correlation with pore pressure at any depth in the boreholes. Overall, there is a trend of either steady decreases of pore pressures with time or maintenance of constant values, with the exceptions of the February 2017 landslide event in BH2a, the BH3a sensor at 20 m and the BH2a

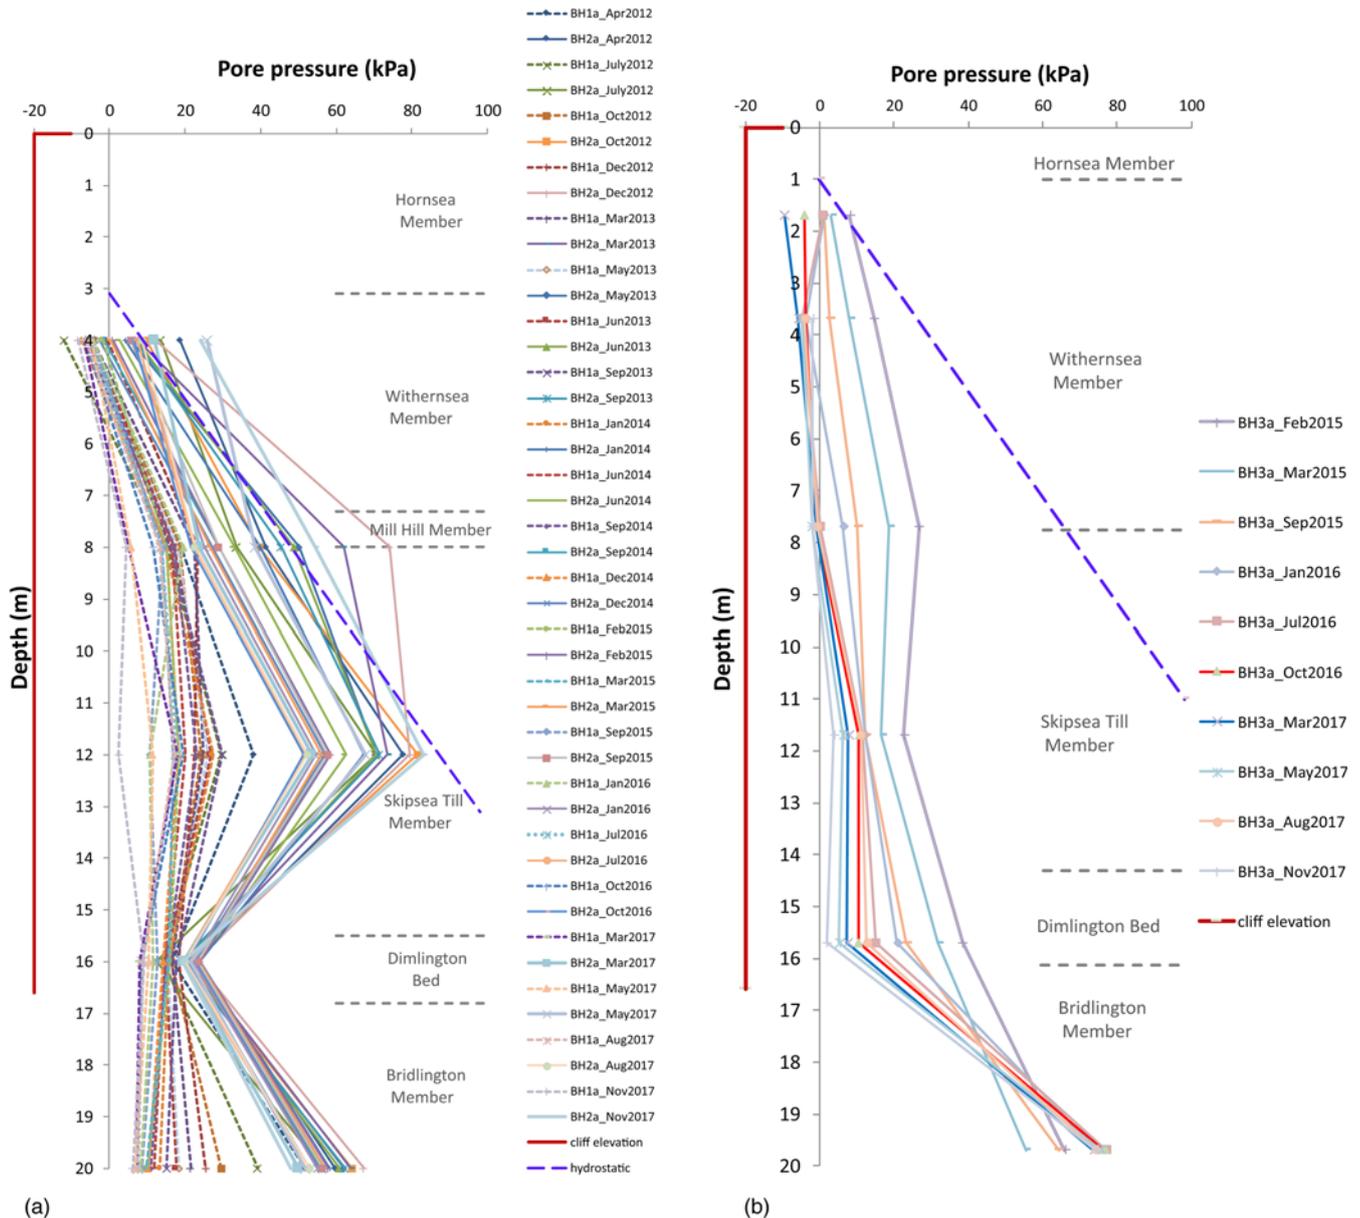
**Fig. 15.** Piezometer 'profile' plots: (a) BHs 1a and 2a; (b) BH3a (BGSCUKRI). No sensors were present in BHs 1a and 2a at 2 m depth. Purple dashed lines represent idealized hydrostatic profiles.

Plots of piezometer borehole profiles for each site visit are shown in Figure 15. These emphasize the markedly sub-hydrostatic nature for Boreholes (BHs) 1a and 3a but less markedly sub-hydrostatic for BH2a down to 12 m. Similar 'depressed' pore pressures were described for the London Clay Formation cliffs at Warden Point (Dixon & Bromhead 2002). The Dimlington Bed, at least in BHs 1a and 2a, acts as a minor source of water to the lower cliff, whereas the Skipsea Till Member in BH2a does not. The Dimlington Bed also saturates the upper parts of the underlying Bridlington Member. Observations of the cliff slope indicate that the Mill Hill Bed is a major source of water to the mid- and lower cliff and, hence, to landslide deposits on the cliff. Pickwell (1878) described 'land springs' as the chief cause of the landslides at Aldbrough. Any mechanism whereby drainage from the Mill Hill and Dimlington Beds is blocked by landslide deposits on the cliff slope is likely to be transient and difficult to observe and quantify. The data indicate that hydraulic continuity with the cliff and between boreholes is in an enhanced state compared with the situation further inland, owing mainly to the presence of persistent joints within the till members and their 'opening up' with time as a result of progressive stress relief as discussed above.

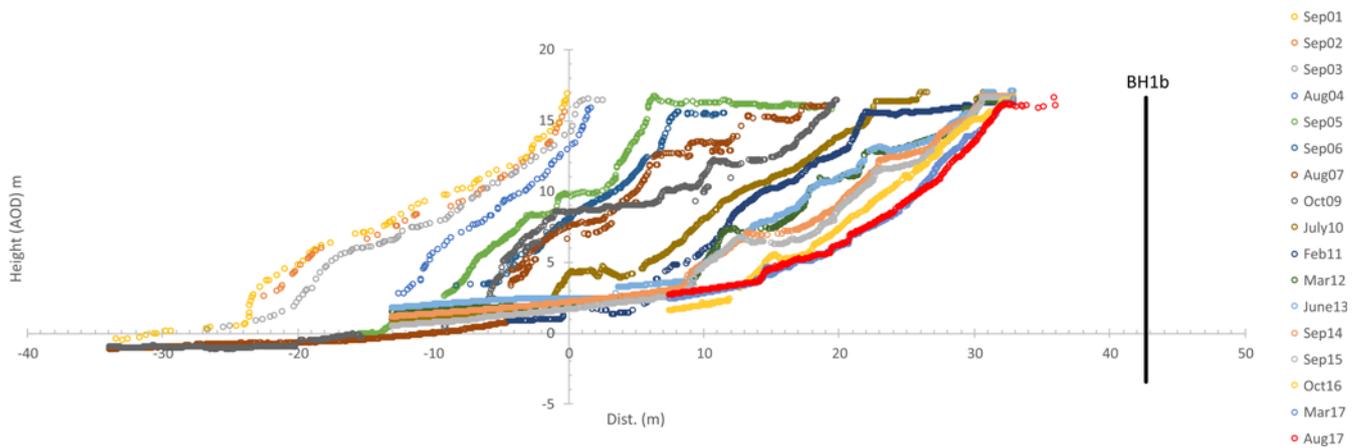
**Fig. 16.** Selected cross-sections aligned with 'b' boreholes, derived from TLS (September 2001 to August 2017: left to right) (BGS@UKRI). Location of BH1b (installed March 2012). March and August 2017 profiles do not illustrate 14 February 2017 landslide event owing to concentration of displacement in southern part of the embayment at this time. Cliff-top displacement between February 2011 and March 2012 profiles was due to subsidence and destruction of concrete roadway.

Cross-sections have been constructed from TLS surveys (Fig. 16) so as to be aligned with the 'b' boreholes. These were then used to create the ground surface profiles for 2D slope stability analyses. The inputs to slope stability analysis also included stratigraphic layers, strength and density data, and hydrological data obtained from the conceptual model (Fig. 5), the last of these probably being the most problematic. Geotechnical data were taken from the testing programme (Hobbs *et al.* 2015b, 2019).

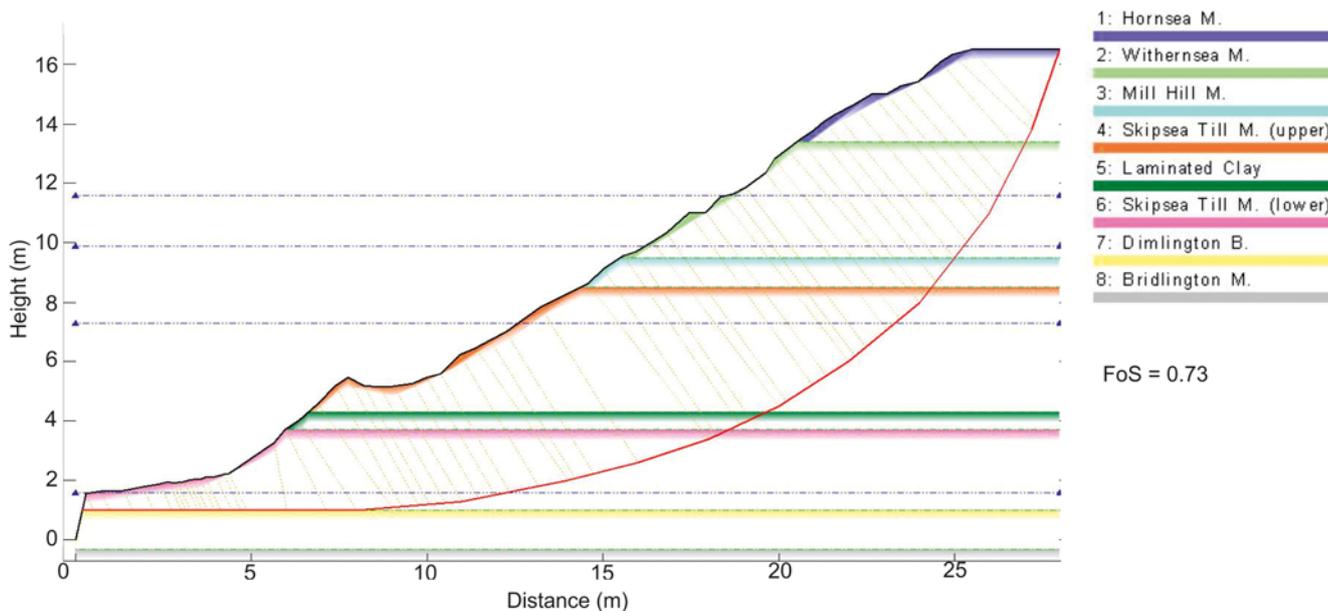
**Fig. 17.** Example of Galena output: Profile aligned with ‘b’ boreholes, October 2016 using residual strength data (BGS©UKRI). Dashed horizontal lines are piezometric levels; continuous red line is slip surface (estimated).

To investigate the engineering stability of the cliff sections, derived from TLS surveys, landslides were modelled in 'Galena' (limit equilibrium) software (v.7.10) supported by 'FLACslope' (finite-element) software (v. 7.0). This approach has the advantage that these two independent methods may be combined to refine each model. A key difference in their use is that the Galena model allows the input of a slip surface whereas the FLACslope model is capable of 'suggesting' one. Examples are taken from the October 2016 TLS survey (Figs 17 and 18), the last before the 14 January 2017 landslide event. The FLACslope model suggests a flattening (no toe uplift) of the slip plane close to the cliff within or close to the level of the Dimlington Bed, thus providing more of a 'composite' style of landslide (Varnes 1978; UNESCO Working Party on World Landslide Inventory 1993), although field evidence suggests this may be exaggerated and reflect the simplified nature of the CLO model in terms of 3D bedding morphology. The Galena example uses multiple piezometric levels for the major lithostratigraphic units and the FLACslope example a single phreatic surface. Details of slope stability methods and results have been given by Hobbs *et al.* (2013) and Parkes (2015).

It will be noted that the examples do not agree regarding Factor of Safety (FoS) but both are significantly less than unity (i.e. unstable). The latter is due, in part, to enhanced suctions close to the cliff face and depressed pore pressures overall but mainly to the use (in this case) of residual strength data. The equivalent FoSs for Galena and FLACslope using 'peak' strength data were 1.26 and 0.92,

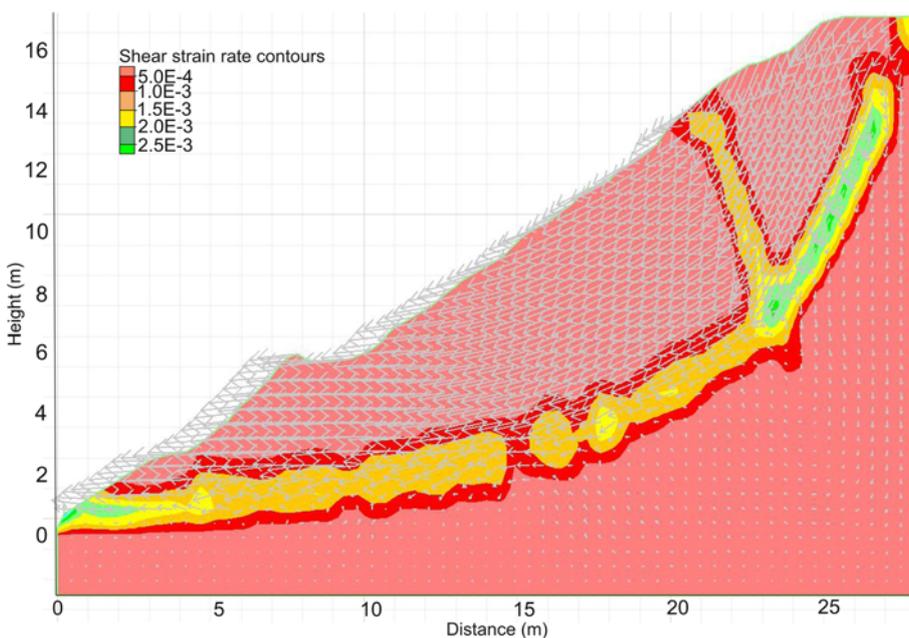
**Fig. 18.** Example of FLACSlope output: profile aligned with ‘b’ boreholes, October 2016 using residual strength data. FoS is 0.44 (BGS©UKRI). Colours indicate shear strain rate contours; arrows indicate displacement vectors.
