# Landslide survey: High Lossit, near Machrihanish Bay, Mull of Kintyre

Internal Report IR/14/035

R Ellen and K Whitbread

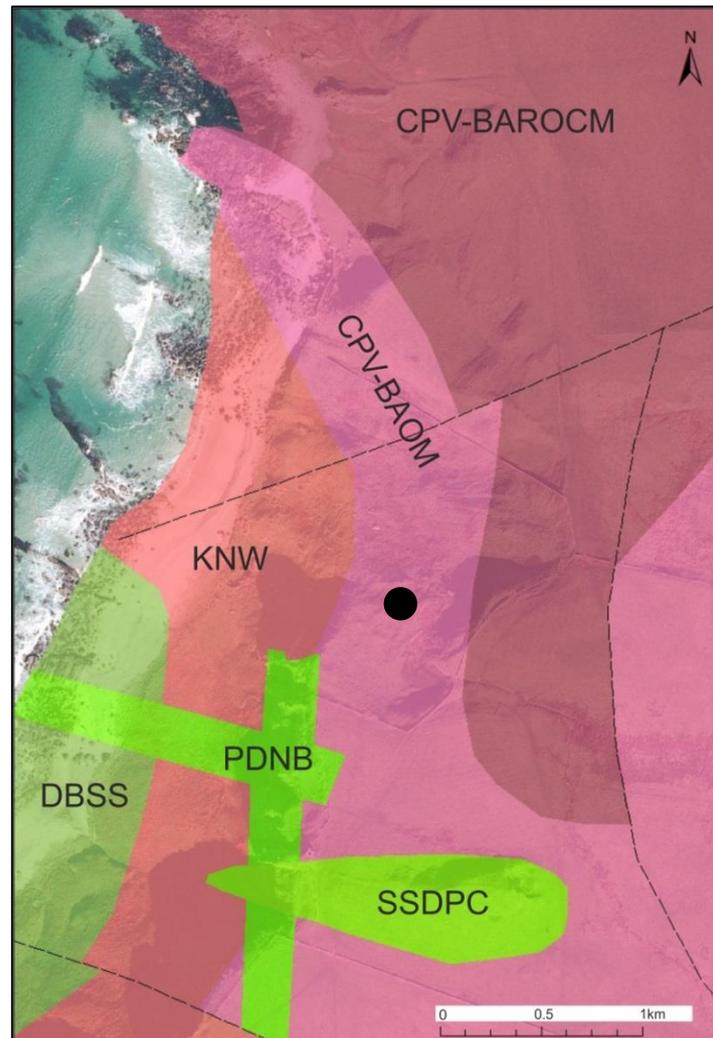
The area lies within British Geological Survey 1:50 000 map Sheet 12, Campbeltown (1996). A geological map of the study area is shown in Figure 3. The geological descriptions given below conform to the BGS Rock Classification Scheme (Gillespie & Styles, 1999; Hallsworth & Knox, 1999; McMillan & Powell, 1999).

interpretation of the aerial photograph (Figure 2). Old scarps are seen bordering a depressed area of ground with an irregular topography containing multiple angular boulders. The boulders consist only of basalt, some exceeding 5 m in size, set in a silty, sandy clay matrix. Evidence of a previous landslide continues seaward, beyond the toe of the recent slide, where a boulder field is preserved below the current high tide mark. However, the definitive extent of the original deposit is complicated by the presence of raised coastline. At the top of the coastal slope the farmer's dry stone wall follows the crown of the relict landslide scarp marking out the southern and eastern edges of the older slip. Outside the area of the 4<sup>th</sup> February landslide event there is evidence for two smaller landslides sourced from the scarp of the older landslip. These minor slips have formed within the altered and highly-weathered basalts (CPV\_BAROCM).

**Figure 3:** Extract from 1:50 000 digital geological map (DigMapGB50, Version 4, 2007) showing bedrock and fault lines (superficial layer not shown). Bedrock Legend: SSDPC, microgabbro (sheet intrusion); PDNB, microgabbro (dyke and sill); CPV-BAROCM, olivine-clinopyroxene-macrophyric basalt; CPV-BAOM, olivine-macrophyric basalt; KNW, Kinnesswood Formation sandstone and limestone; DBSS, Stonefield Schist Formation. The black dot shows the National Landslide Database location (Landslide ID 19462). *Geological map* © NERC 2013. All rights reserved. *Aerial photograph* © Getmapping; Licence Number UKP2006/01.
