The anaerobic corrosion of candidate disposal canister materials in compacted bentonite exposed to natural granitic porewater containing native microbial populations

The Materials Corrosion Test (MaCoTe) is a long-term, multi-national *in situ* corrosion experiment set up at the Grimsel Test Site, Switzerland. The experiment has been operating since 2014 with a focus on the corrosion behaviour of container materials for the disposal of high-level waste and spent nuclear fuel under conditions representing a granitic deep geological repository. The experiment consists of eight modules containing metal coupons and bentonite. Two of the modules, each with a different bentonite density, have been retrieved after 394 days of exposure and have been analysed using a range of techniques aimed at studying the corrosion behaviour of the metals and the mineralogical evolution of the bentonite. Weight loss measurements show that carbon steel had a relatively low average corrosion rate ($\sim 2 \mu\text{m yr}^{-1}$). Much lower average corrosion rates were measured for the various types of copper (0.13 to $0.32 \mu\text{m yr}^{-1}$). No detectable corrosion was measured on stainless steel coupo

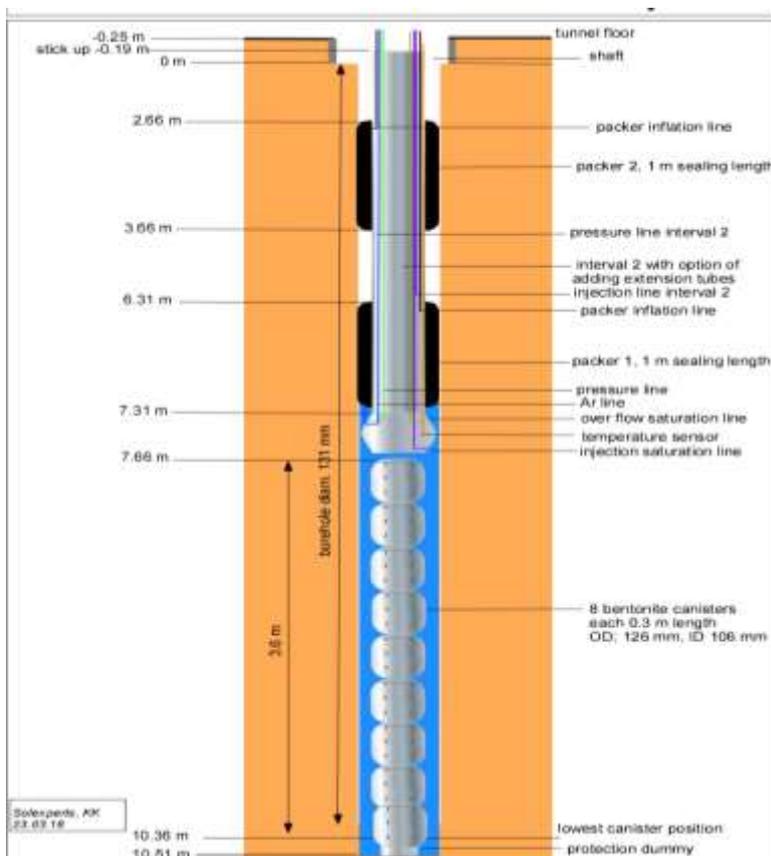
The experimental set-up consists of a single, vertical-descending borehole which is sealed from the environment with a double packer system. In the borehole, several modules containing metal coupons and bentonite are exposed to natural granitic porewater under anoxic conditions, as shown in Figure 1. The external dimensions of the modules are 250 mm length with a diameter of 126 mm. The walls of the module contain holes allowing the ingress of groundwater. A liner is used inside the module to control the initial volume and resulting swelling of the bentonite (3 mm thick cylindrical sintered stainless steel filter with an average pore size of 18 μm and a porosity of 30%). The experimental set-up and module design is practically identical to the one used in the IC-A experiment at Mont Terri [13], allowing for comparisons between clay and granitic host rocks and associated groundwaters.

Figure 1. MaCoTe experimental layout at the Grimsel Test Site (GTS).

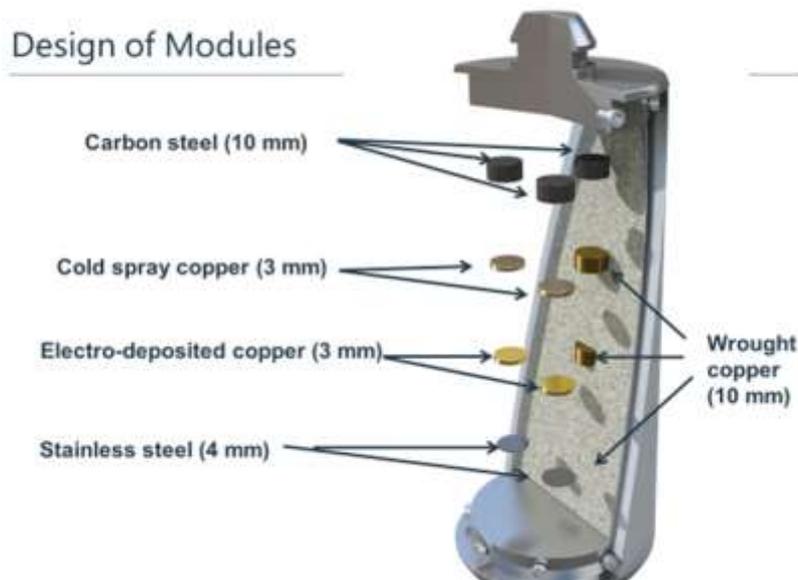
The module housing and associated sintered filters were cleaned with acetone and deionized water. The layout of the coupons in the module are shown in Figure 2.

Figure 2. Illustration of stainless steel module and its contents, including layout of coupons.

The thickness of the cylindrical coupons is given in parentheses.

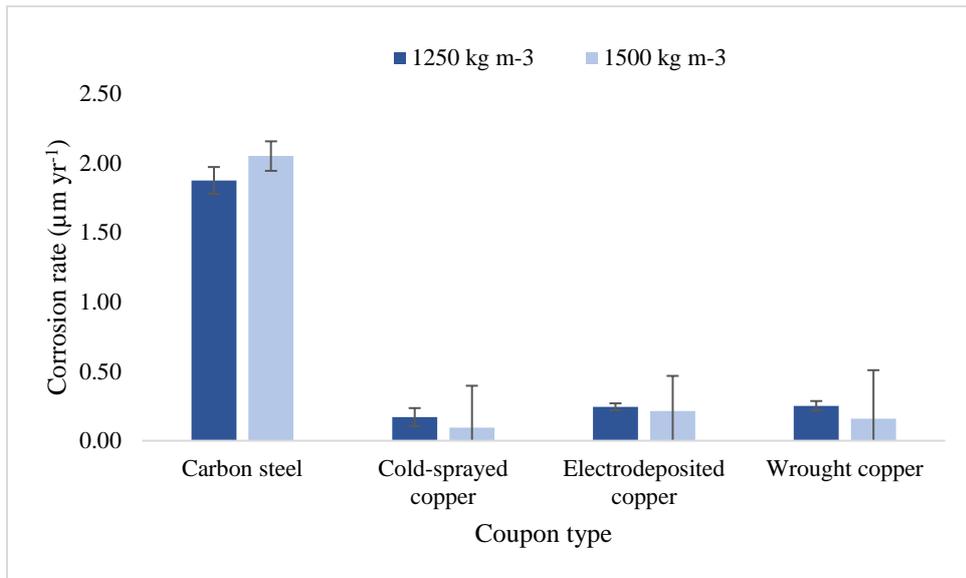
The average corrosion rates for the exposure period of 394 days are shown in Figure 3. The corrosion rate of carbon steel ranged from $1.87 \mu\text{m yr}^{-1}$ to $2.05 \mu\text{m yr}^{-1}$, while the corrosion rates for the various copper coupons were much lower and the corrosion rate of stainless steel was negligible. At a bentonite density of 1250 kg m^{-3} the cold-sprayed copper had an average corrosion rate of $0.17 \mu\text{m yr}^{-1}$ whilst the electrodeposited and wrought copper had an average corrosion rate of $0.24 \mu\text{m yr}^{-1}$. At a bentonite density of 1500 kg m^{-3} , copper average corrosion rates were between 0.09 and $0.21 \mu\text{m yr}^{-1}$, with upper uncertainty levels of approximately $\pm 0.5 \mu\text{m yr}^{-1}$. Note that, as a result of successful developments in the weight loss methodology, uncertainties calculated for copper samples extracted from the module with a bentonite density of 1250 kg m^{-3} were lower than those calculated for copper samples extracted from the bentonite with a density of 1500 kg m^{-3} , which were used in initial trials. This is not expected to reflect differences in corrosion behaviour between the two bentonite densities, only differences in methodology used to evaluate uncertainty.

Figure 3. Average corrosion rates for carbon steel, and cold sprayed, electrodeposited and wrought copper in bentonite with densities of 1250 kg m⁻³ and 1500 kg m⁻³ after a nominal exposure period of 394 days.

The average corrosion rate of carbon steel was approximately $1.96 \mu\text{m yr}^{-1}$, with the corrosion rate being about 5% higher in bentonite with a density of 1500 kg m^{-3} compared to 1250 kg m^{-3} . These corrosion rates are comparable to those measured over similar durations in Opalinus Clay ($1.2\text{-}2.1 \mu\text{m yr}^{-1}$ after 694 days) [12].

The average corrosion rate of the copper coupons, irrespective of bentonite density, was between 0.09 and $0.25 \mu\text{m yr}^{-1}$, an order of magnitude lower than the carbon steel samples. Corrosion rates of copper were also similar to those found in the above mentioned experiment at Mont-Terri [14] ($0.02\text{-}0.2 \mu\text{m yr}^{-1}$ after 1024 days). However, the measured rate was higher than those found, after longer emplacement periods, in Module 4 of the MiniCan experiment [31] conducted in the Aspö rock laboratory ($0.02 \mu\text{m year}^{-1}$ after 9 years). Due to the possible ingress of oxygen during transport due to the damaged packaging, the reported corrosion rates may not be representative of totally anoxic conditions, even though they seem to agree with values from literature where oxygen was not a concern. Similarly, the surface roughness, R_a , for carbon steel and copper coupons after exposure is comparable to the values from the Mont Terri in situ experiment ($1.0\text{-}1.4 \mu\text{m}$ for carbon steel after a period of 694 days, $\sim 1 \mu\text{m}$ for copper after 1024 days [12]). The similarities between the corrosion rates in clay and granitic environments are probably due to the fact that the chemical environment at the coupon surface is primarily dictated by the bentonite, supported by the fact that the composition of the rock porewaters in Mont Terri and Grimsel are not significantly different [24,30]

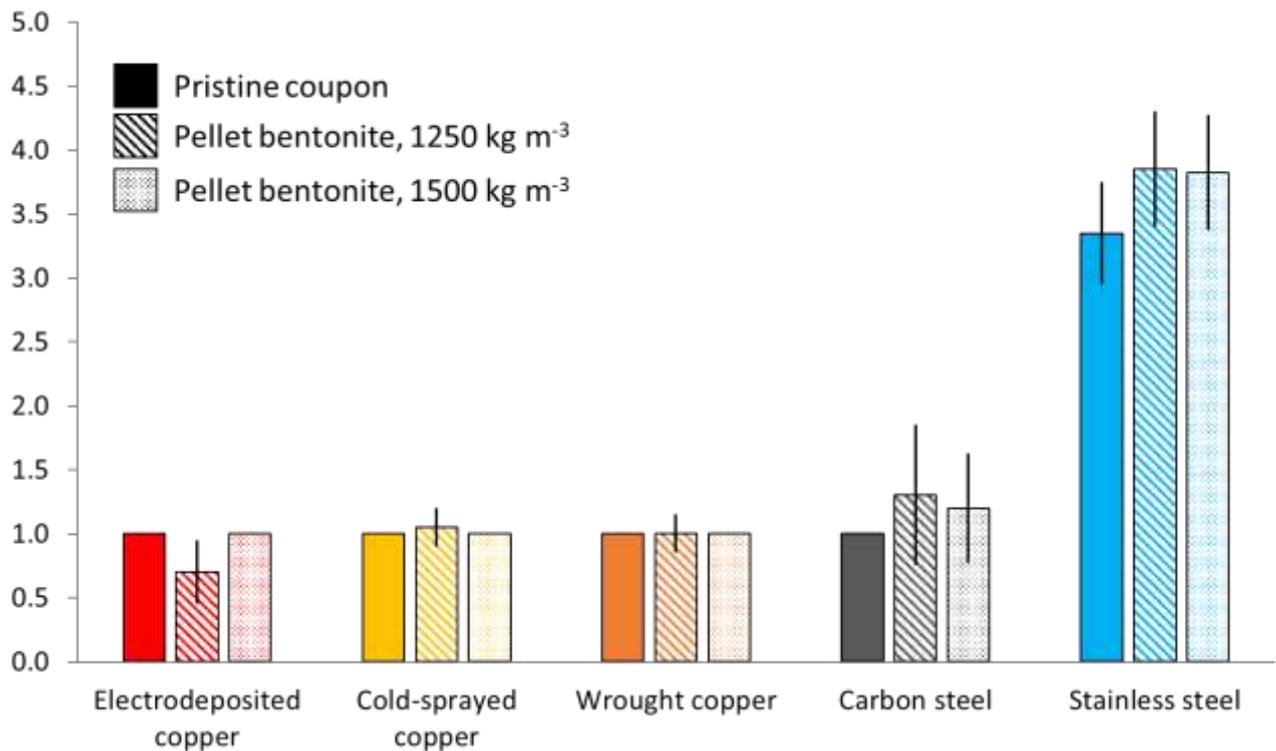
The profilometry measurements for pristine coupons and coupons after exposure are shown in Figure 4. For all materials, the roughness after exposure were similar to those of pristine samples, indicating pitting or surface roughening did not occur or was minimal.

Figure 4. Average roughness (Ra) values for pristine coupons and coupons exposed in situ for a nominal duration of 394 days within bentonite with a dry density of 1250 and 1500 kg m⁻³.

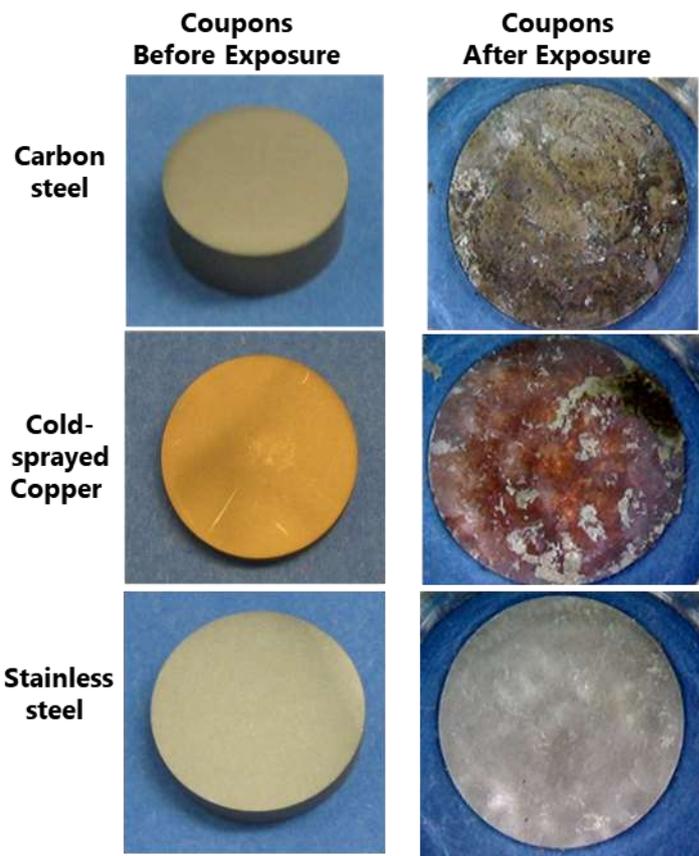
Optical images of carbon steel, copper and stainless steel coupons before and after exposure are shown in Figure 5. The carbon steel coupons showed a widespread greyish/black colour and, in some areas, brownish colouration. Copper samples showed reddish colouration on top of an otherwise metallic-copper surface. Stainless steel samples looked darker but closer inspection suggested that such darkening was associated with adhering bentonite.

Figure 5. Optical images of carbon steel, stainless steel and copper coupons before and after in situ exposure for 394 days to bentonite with a density of 1250 kg m^{-3} .

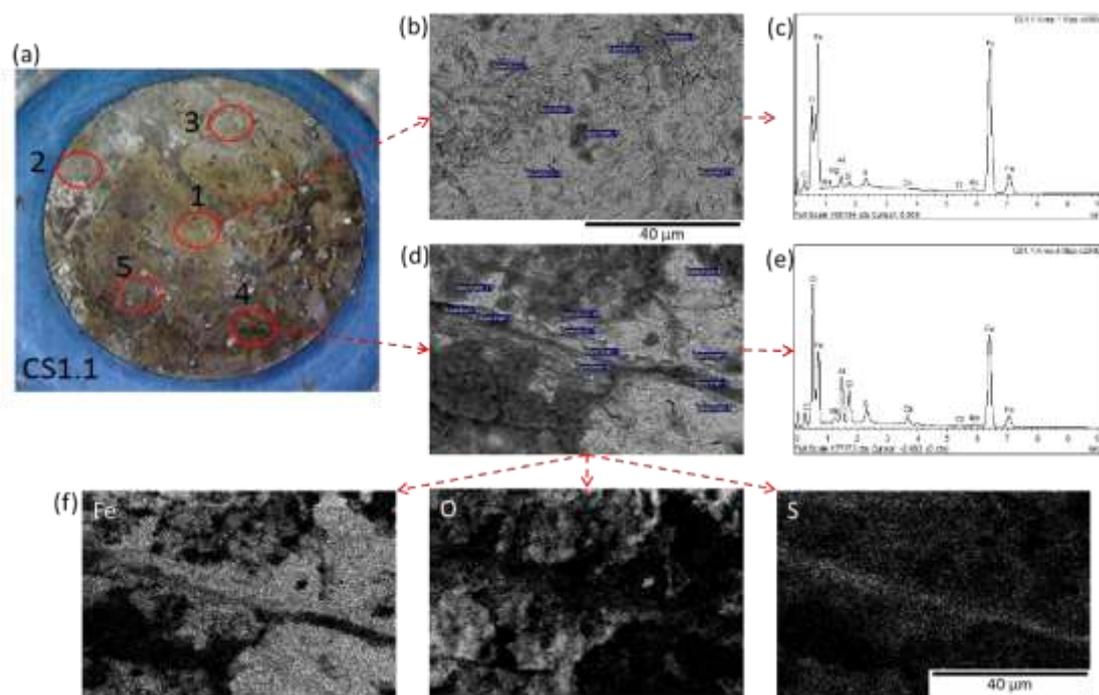
SEM and EDX analyses were carried out on a selection of copper, stainless steel and carbon steel coupons removed from the modules. Data collected on carbon steel and copper are shown in Figure 6 and Figure 7 respectively. As expected from the optical images, the surface of all materials was inhomogeneous with some areas appearing darker under the SEM which consisted of adhering bentonite (Si, Al, O).

In the case of carbon steel, the areas not covered with bentonite (brighter under the SEM) showed greater amounts of iron and oxygen, suggesting the presence of iron corrosion products or bentonite alteration phases containing iron. In the case of copper, in some spots Al and O are present in the absence of Si which seems to be correlated to surface preparation with grit blasting with alumina particles. Other areas (brighter under the SEM) were characterised by a strong copper signal. In the case of stainless steel (not shown), apart from areas containing elements typically associated with bentonite, no others sign of surface alteration where found. For all metals, there were no significant differences between coupons exposed in bentonite with different densities.

Figure 6. SEM-EDX analysis of carbon steel after in situ exposure for 394 days to bentonite with a density of 1250 kg m^{-3} ; (a) optical image of coupon, with analysis areas marked; (b, d) backscattered electron image of areas 1 and 4; (c, e) overall EDX spectrum of areas 1 and 4; (f) elemental maps acquired from area 4.

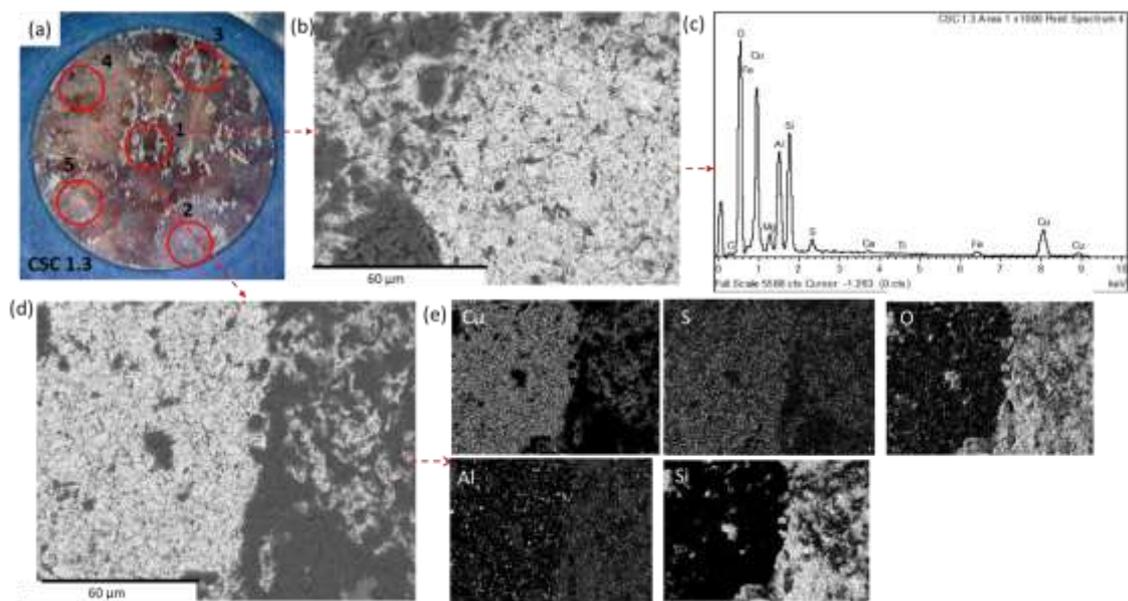
Figure 7. SEM-EDX analysis of cold sprayed copper after in situ exposure for 394 days in bentonite with a density of 1250 kg m^{-3} . (a) optical image of coupon, with analysis areas marked. (b, d) backscattered electron image of areas 1 and 4; (c) overall EDX spectrum of area 1, (e) elemental maps acquired from area 4.

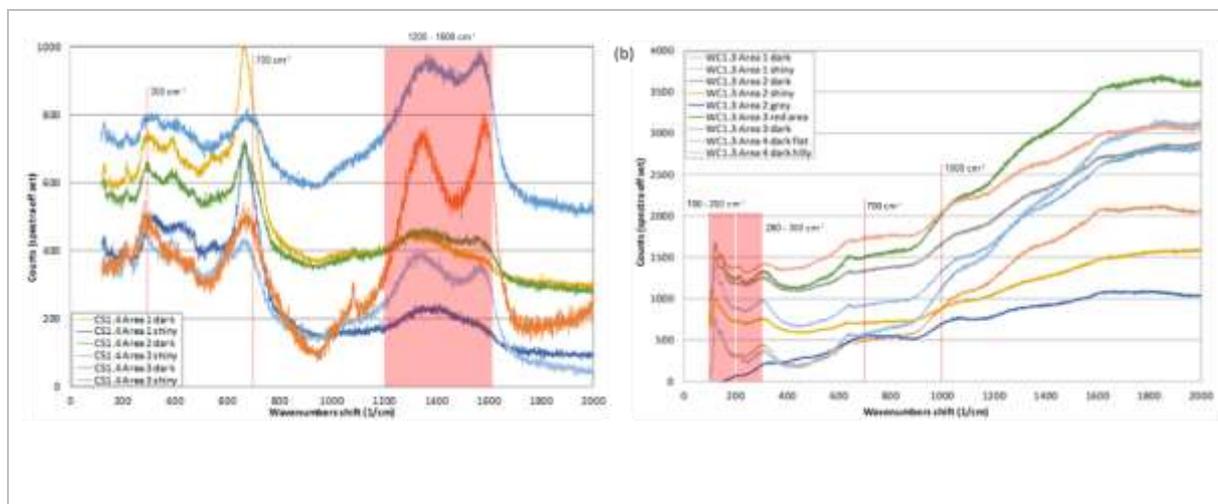
Raman spectra obtained from several areas on a carbon steel and on a wrought copper coupon are shown in Figure 8. For carbon steel, the main peaks observed were centred at 300 cm^{-1} (attributed to haematite, and/or possibly FeOOH), 700 cm^{-1} (attributed to magnetite) and a doublet peak in the $1200\text{-}1600\text{ cm}^{-1}$ region, which could potentially be attributed to the presence of graphite or iron-carbide [26]. The spectra for different areas of the wrought copper coupon were very similar, with a number of peaks in the $100\text{-}300\text{ cm}^{-1}$ region. These peaks match with a number of copper corrosion products (e.g. Cu_2O and CuO), so no specific products can be distinguished from them. The magnitude of the peaks in the region attributed to Cu_2O ($100\text{-}200\text{ cm}^{-1}$) is greater than that attributed to CuO ($200\text{-}300\text{ cm}^{-1}$), which may be indicative of the relative amounts of the two products. Peaks centred at 700 and 1000 cm^{-1} are also apparent in some spectra. These peaks do not appear to match the reference spectra for common copper corrosion products.

Figure 8. Raman spectra after in situ exposure for 394 days in bentonite with a density of 1250 kg m^{-3} , (left) carbon steel, (right) wrought copper.

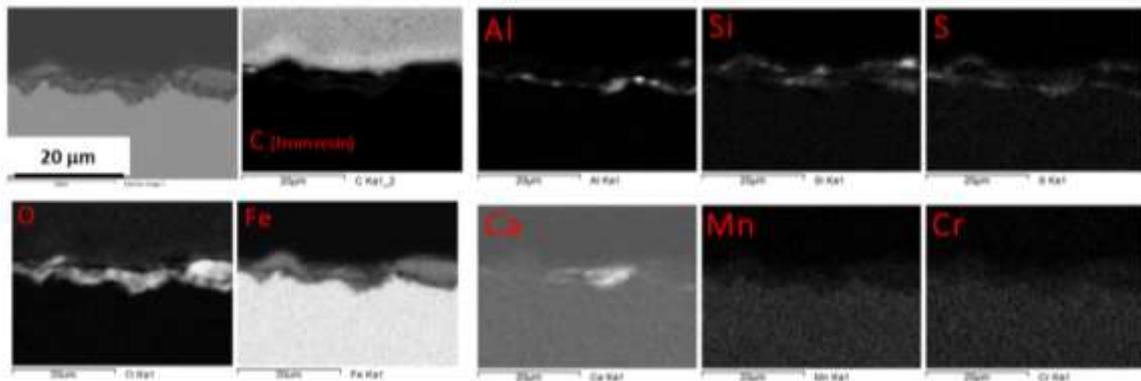
Representative optical and SEM-EDX analysis results of cross-sectioned carbon steel and wrought copper coupons are presented in Figure 9 and Figure 10, respectively. The main features of the analysis of carbon steel (bentonite density 1250 kg m^{-3}) were as follows:

- Sulphur, silicon and aluminium were present close to the metal surface. Given the presence of Fe, it is possible that these regions are the result of interactions between the bentonite and the corroding steel, rather than being fragments of bentonite that remained attached to the coupon.
- Iron was found in some areas associated with O only (e.g. right hand side of the alteration layer in Figure 9). This suggests that in some regions corrosion products exist without being intermixed with bentonite phases. Using the Fe signal as an indicator, the thickness of the corrosion product layer was estimated at approximately $5 \mu\text{m}$.

Figure 9. SEM image (top left) and EDX elemental maps of cross-section of carbon steel after in situ exposure for 394 days in bentonite with a density of 1250 kg m^{-3} .

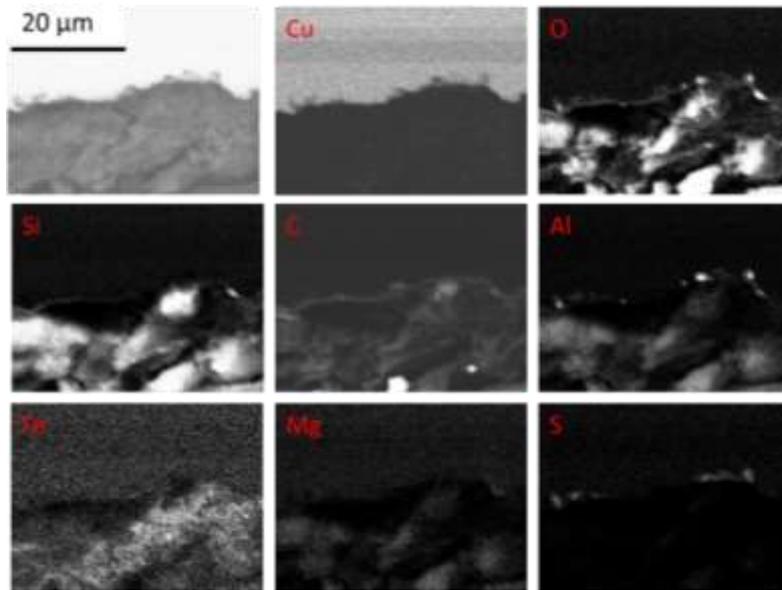
The main features of the analysis of copper (bentonite density 1250 kg m^{-3}) were as follows:

- It was not possible to discern evidence of a widespread surface alteration layer.
- In specific areas, a thin ($\ll 1 \mu\text{m}$) layer enriched in O, C and Si was present at the metal/resin interface. It is likely that the C and O signals were the result of the use of the mounting resin. It is also possible that the Si and O signals were associated with a thin, adhering bentonite layer (consistent with XPS measurements). Al seems to be present in few isolated particles, where a strong presence of O signal indicating that it is the result of sample preparation (alumina grit blasting).
- S was found only in contact with the copper surface in isolated areas and associated with sub-micron surface features, indicating a corrosion process.

Figure 10. SEM image (top left) and EDX elemental maps of cross-section of wrought copper after in situ exposure for 394 days in bentonite with a density of 1250 kg m^{-3} .

Figure 15 shows SEM micrographs of the copper-bentonite interface, this time reproducing surface SEM images collected on an area of the bentonite previously in contact with a copper coupon. The images show that the alteration layer seen in Figure 14, consists of submicron particles rich in copper and sulphur interspersed in the bentonite. This finding is in agreement with the cross-section shown in Figure 10, where Cu-S-based particles were found adherent on the metallic surface.

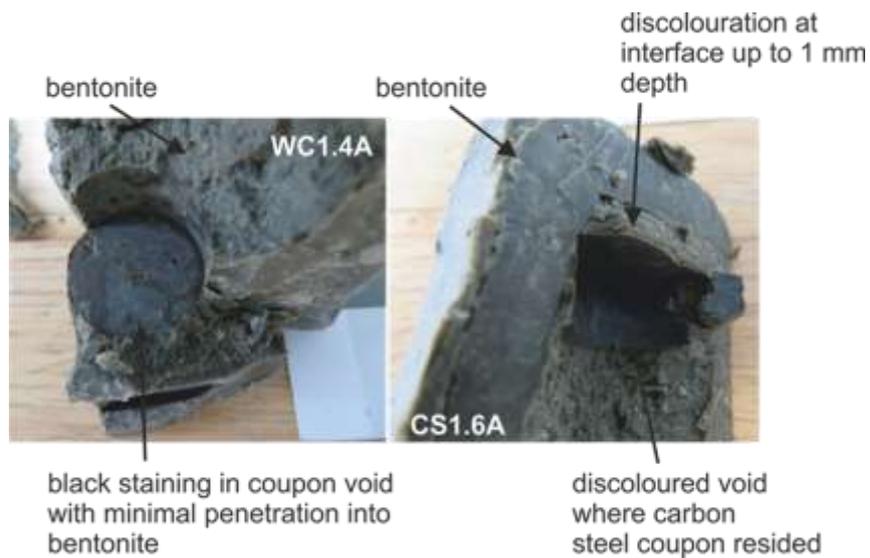
Optical images of the bentonite surrounding carbon steel and wrought copper coupons after exposure are shown in Figure 11. The bentonite matrix immediately adjacent to the carbon steel coupon had a black colour, while it was stained with a reddish-brown colour over an area $\sim 1 \text{ mm}$ thick surrounding the coupon. For copper, the staining in the bentonite was much less, with some parts of the bentonite surface in direct contact with the copper appearing black but the staining did not penetrate into the bentonite matrix. No discoloration was found on the bentonite in contact with the stainless steel coupons.

Figure 11. Visual appearance of bentonite with a density of 1500 kg m^{-3} surrounding wrought copper (left) and carbon steel (right).

In the case of copper, the formation of phases rich in Cu, S, and partly O, would appear to be responsible for the black staining on the bentonite contact surface, with the colour being consistent with a copper sulphide such as chalcocite (Cu_2S) or with a black copper oxide such as tenorite (CuO). The depth of this fringe was very limited and did not penetrate into the adjacent bentonite. The close correspondence of copper and sulphur would be consistent with the formation of a secondary copper sulphide phase. However, semi-quantitative EDX indicates Cu : S ratios that are considerably greater than the ratio of 2:1 expected for the simple cuprous sulphide, chalcocite (Cu_2S). Therefore, this secondary copper-sulphur-rich alteration product may be dominated by copper oxide with only a minor component of copper sulphide rather than a stoichiometrically simple single phase. Apart from enrichment in copper, the bentonite next to the coupons exhibited no other mineralogical or structural alteration.

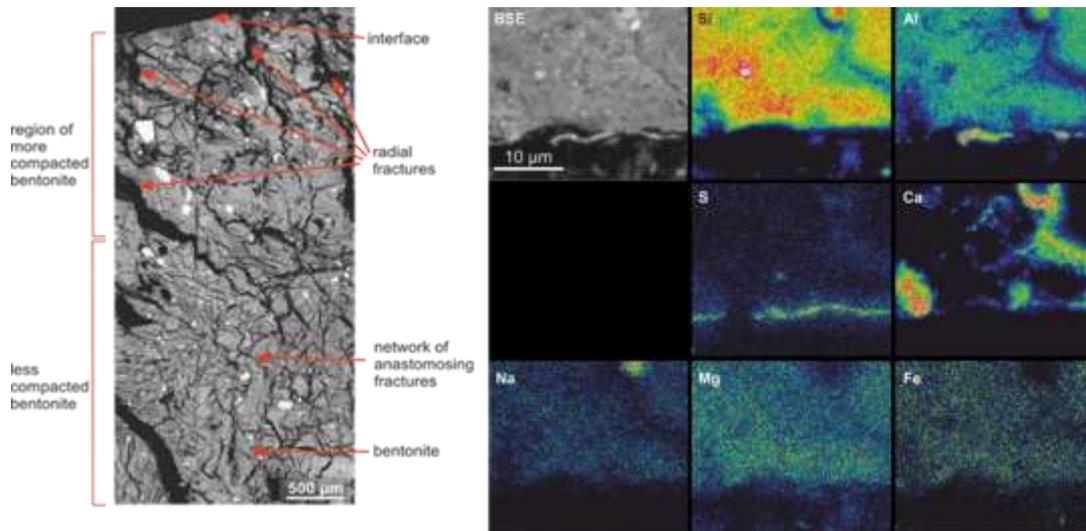
SEM micrographs and EDX elemental maps of the bentonite-coupon interface for carbon steel are presented in Figure 12. A section of bentonite collected $\sim 15 \text{ mm}$ away from a carbon steel coupon is shown in Figure 13.

Figure 12. SEM image of bentonite next to the interface with a carbon steel coupon (left), and high magnification BSE image and corresponding EDX microchemical maps of the interface after in situ exposure of 394 (bentonite density 1500 kg m^{-3}) (right). Colour concentration scale: red > yellow > green > blue > black.

Bentonite had a difference in texture within ~2 mm of the steel surface (Figure 12, left). Adjacent to the interface, the bentonite appeared to be relatively densely-compacted, with radial shrinkage fractures. Most of these shrinkage fractures penetrated well beyond the visible brown stained halo (~1 mm from the interface). Some of this fracturing was probably created or enhanced by drying during sample preparation. Further into the bentonite matrix, the bentonite was noticeably less compact, and had a more open fabric containing an intense network of anastomosing microfractures formed sub-parallel to the interface surface. The bentonite also showed similar features and compaction within the first millimetre from the experimental cell (not shown), suggesting that such morphological changes are associated with mechanical effects and are not related with corrosion processes.

Along the interface of the bentonite with the carbon steel coupon, high-resolution mapping and BSE imaging revealed a thin layer lining the interface (Figure 12, right). EDX mapping showed that this was due to an enrichment in sulphur, with some corresponding, subordinate enrichment in aluminium and calcium. In other areas (not shown), regions rich in iron were found, which also contained sulphur, similar to what was observed for the distal section (see Figure 13). The geometry of these areas suggests that such regions may have been fractures filled with phases formed as a result of the evolution of the system, including iron released by corrosion processes.

High magnification SEM cross sections EDX elemental maps of a cross section of the bentonite-copper interface are presented in Figure 14. The interface showed a 1-2 μm thick area characterised by a speckled, microgranular appearance, comprising the original smectitic clay (i.e. aluminium and silicon) but strongly enriched in copper and, to a lesser extent, sulphur. The oxygen signal overlapped with the Cu- and S-rich region, but it is not possible to assess if it originates in the bentonite or in the copper corrosion product. This layer was discontinuous along the full length of the interface. The bentonite texture close to the copper coupon was similar to the one close to the carbon steel coupon and the stainless steel filter (Figure 12, left), further confirming that this is primarily a mechanical effect, unrelated to corrosion.

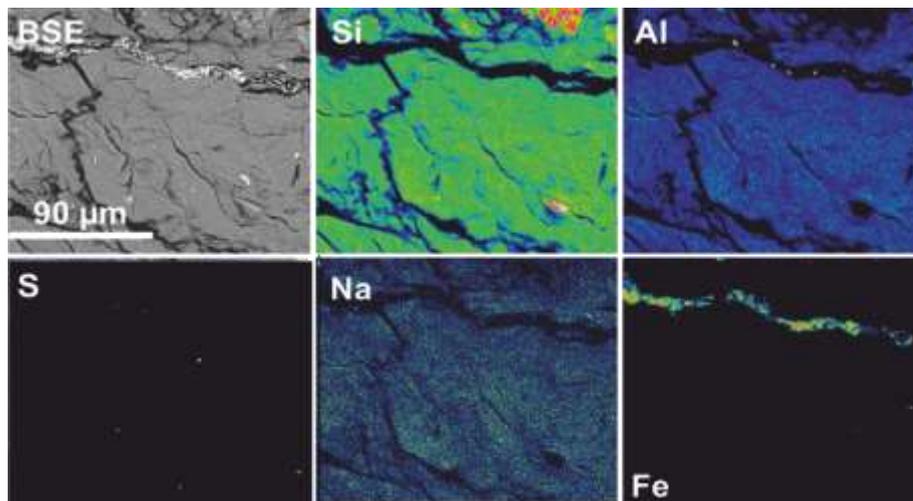
Figure 13. BSE high magnification image of a fracture within bentonite specimen collected ~15mm from steel interface (carbon steel, bentonite density 1500 kg m^{-3}) and corresponding EDX microchemical maps. Colour concentration scale: red > yellow > green > blue > black.

Further away from the steel coupon (~15 mm, Figure 13), bright particles (<5 μm), identified by EDX as Fe-rich (probably Fe oxides), were lining fractures in the bentonite. These were concentrated on the distal side of the thin section and become less numerous towards the proximal side of the section. In some fractures, these particles were densely concentrated, completely infilling the pore space within the fractures. Interestingly, these particles contained no sulphur, which was only identified next to the metal-bentonite interface. The reason for this difference is currently unclear.

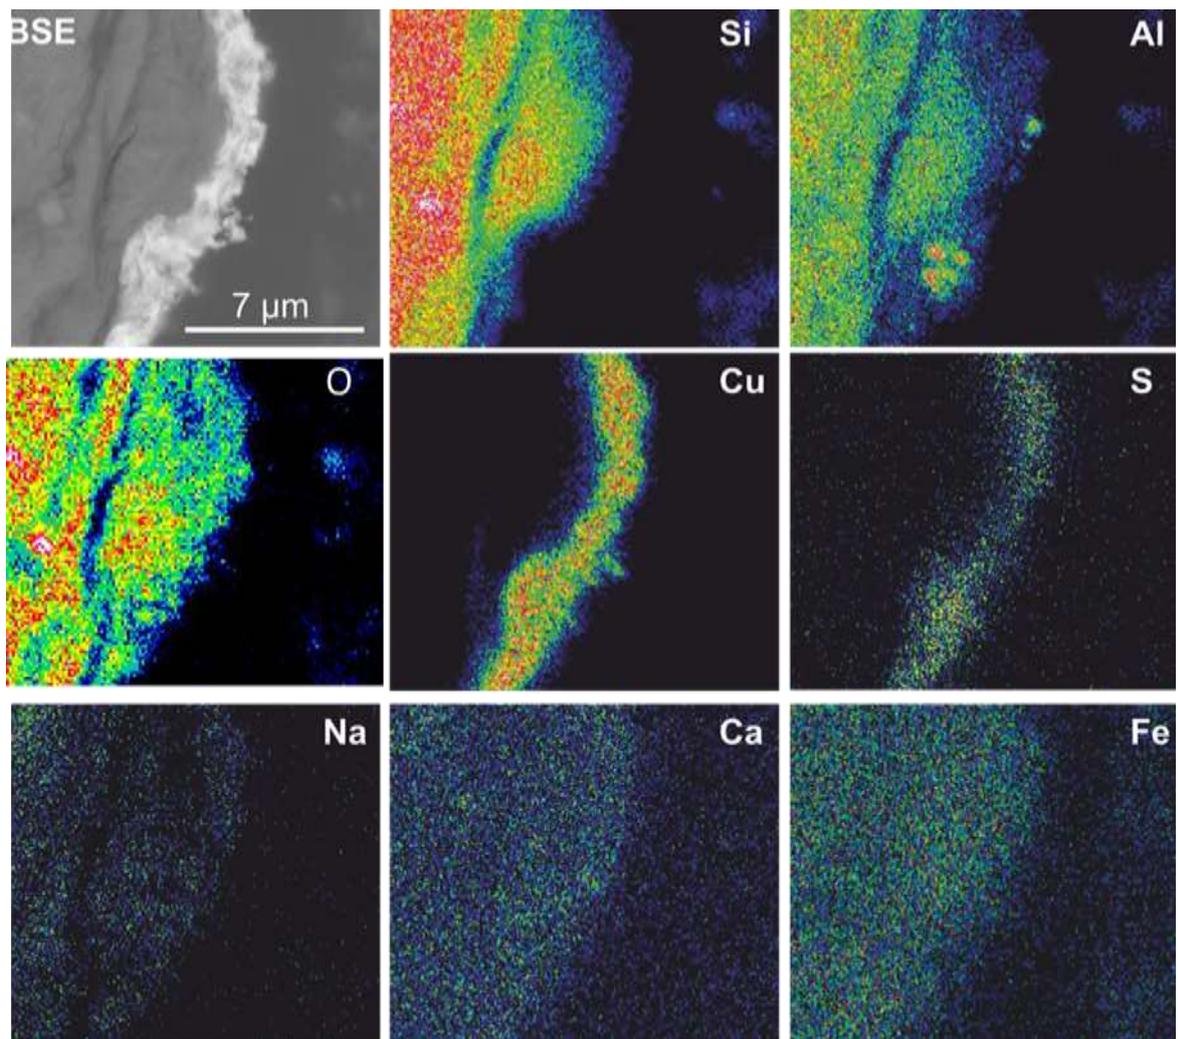
Figure 14. BSE image and corresponding EDX microchemical maps of bentonite specimen in contact with copper coupon (wrought copper, bentonite density 1500 kg m^{-3}). The mapped area is of the bentonite- copper interface. Colour concentration scale: red > yellow > green > blue > black.

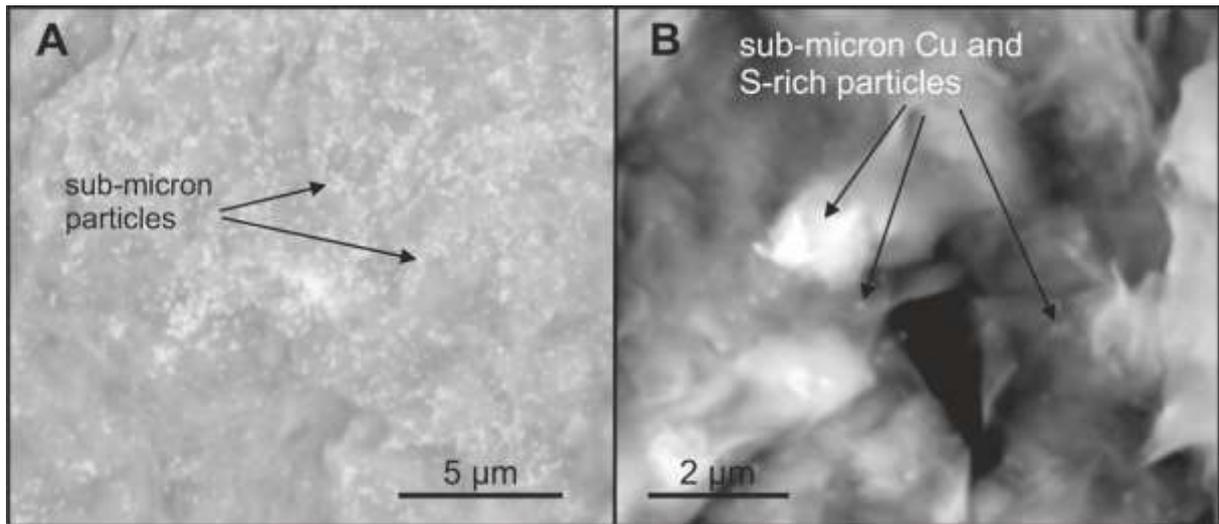
Figure 15. Surface BSE image of bentonite previously in contact with a copper coupon (wrought copper, bentonite density 1500 kg m^{-3}).

Differently than in the case of carbon steel, no sulphur or carbonate were detected on the surface of copper using XPS. However, the SEM/EDX of cross sections indicated that a copper-containing bentonite phase and sparse submicron Cu-S-rich particles were present at the copper-bentonite interface. It seems likely that such phase and particles are a result of corrosion and remained adherent on the bentonite.
